**STATUS REPORT FOR THE SUBMERGED REEF BALL™
ARTIFICIAL REEF SUBMERGED BREAKWATER
BEACH STABILIZATION PROJECT FOR
THE GRAND CAYMAN MARRIOTT HOTEL**

performed by Lee E. Harris, Ph.D., P.E.
Consulting Coastal Engineer
Assoc. Professor of Ocean Engineering
Florida Institute of Technology
Melbourne, Florida 32901 USA

August 2003

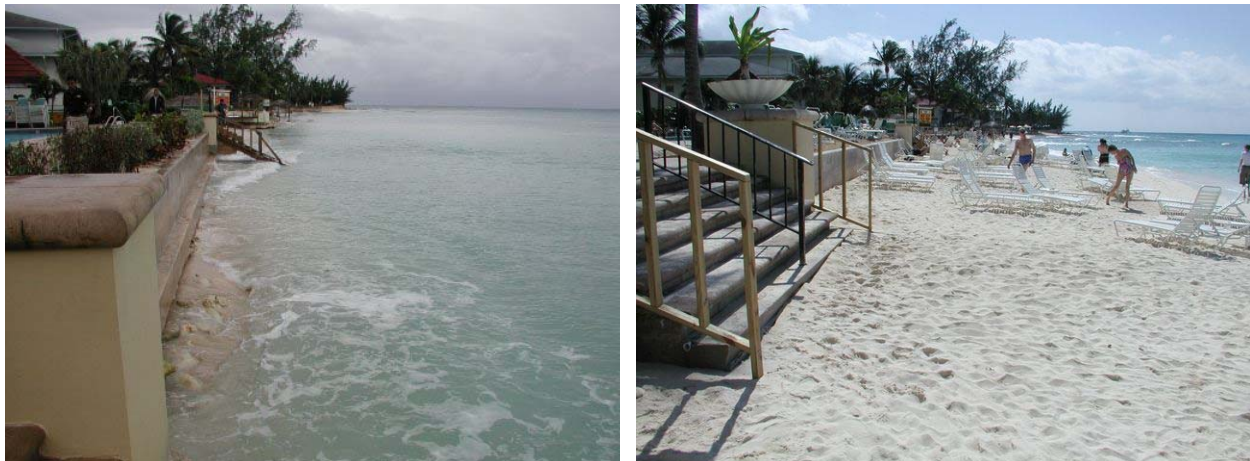
Figure 1. Before and After Breakwater Installation Photographs – View South
October 2002 (left) and February 2003 (right)

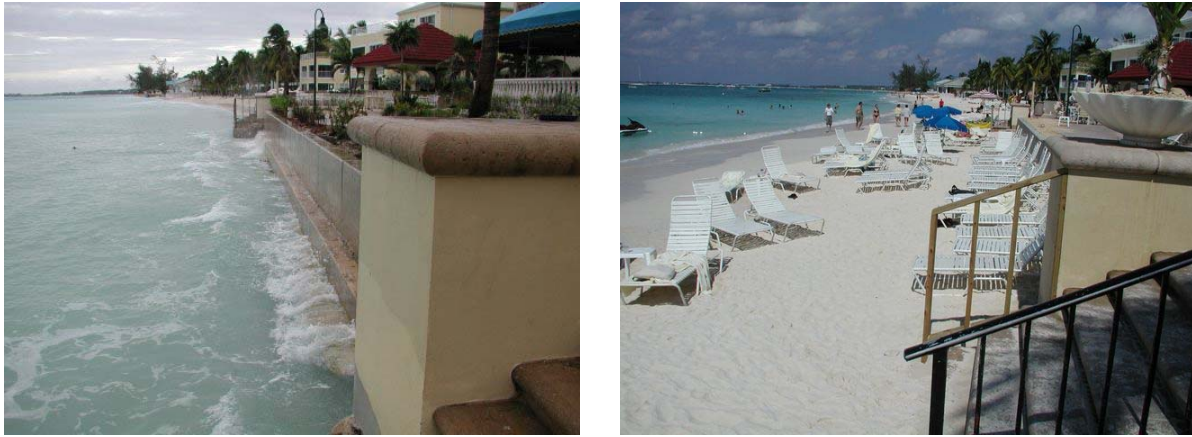
Figure 2. Before and After Breakwater Installation Photographs – View North

October 2002 (left) and February 2003 (right)

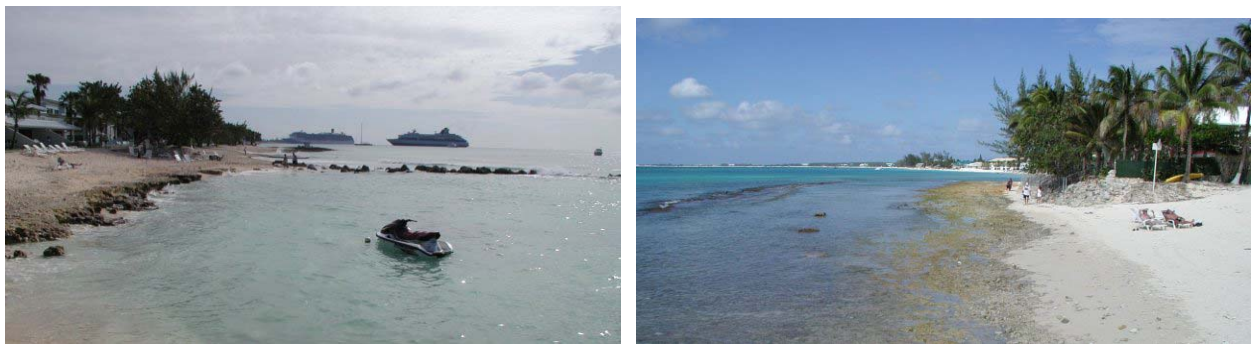
Figure 4. View SW towards the Port showing the existing Groins south of the Marriott (left); and view N towards Seven Mile Beach showing the rocky coast south of the Marriott

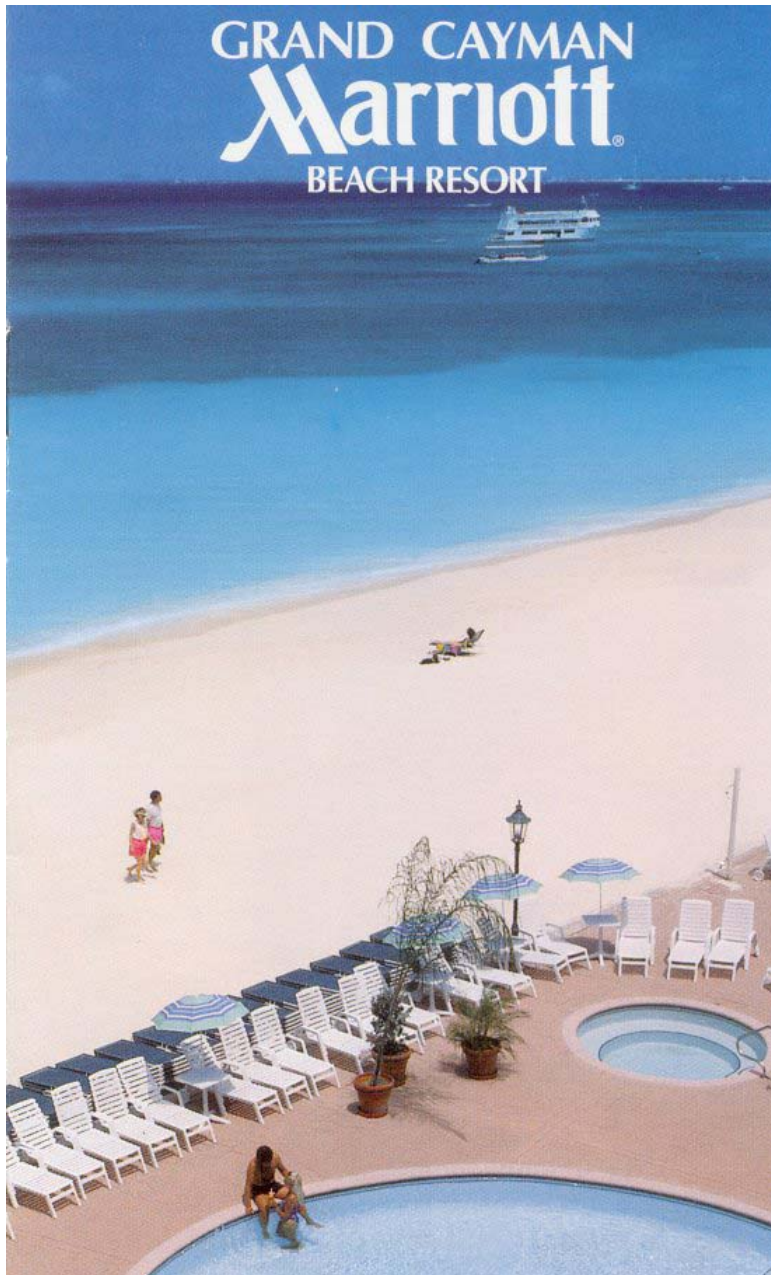
Figure 5 shows the previous beach width at the Marriott Resort prior to 1994 (source, Marriott Brochure), compared to the much narrower beach widths in recent years. Beach width measurements are presented in the following section.

Figure 5. Photograph of the Beach Width at the Marriott Resort prior to 1994
(from Marriott Brochure)

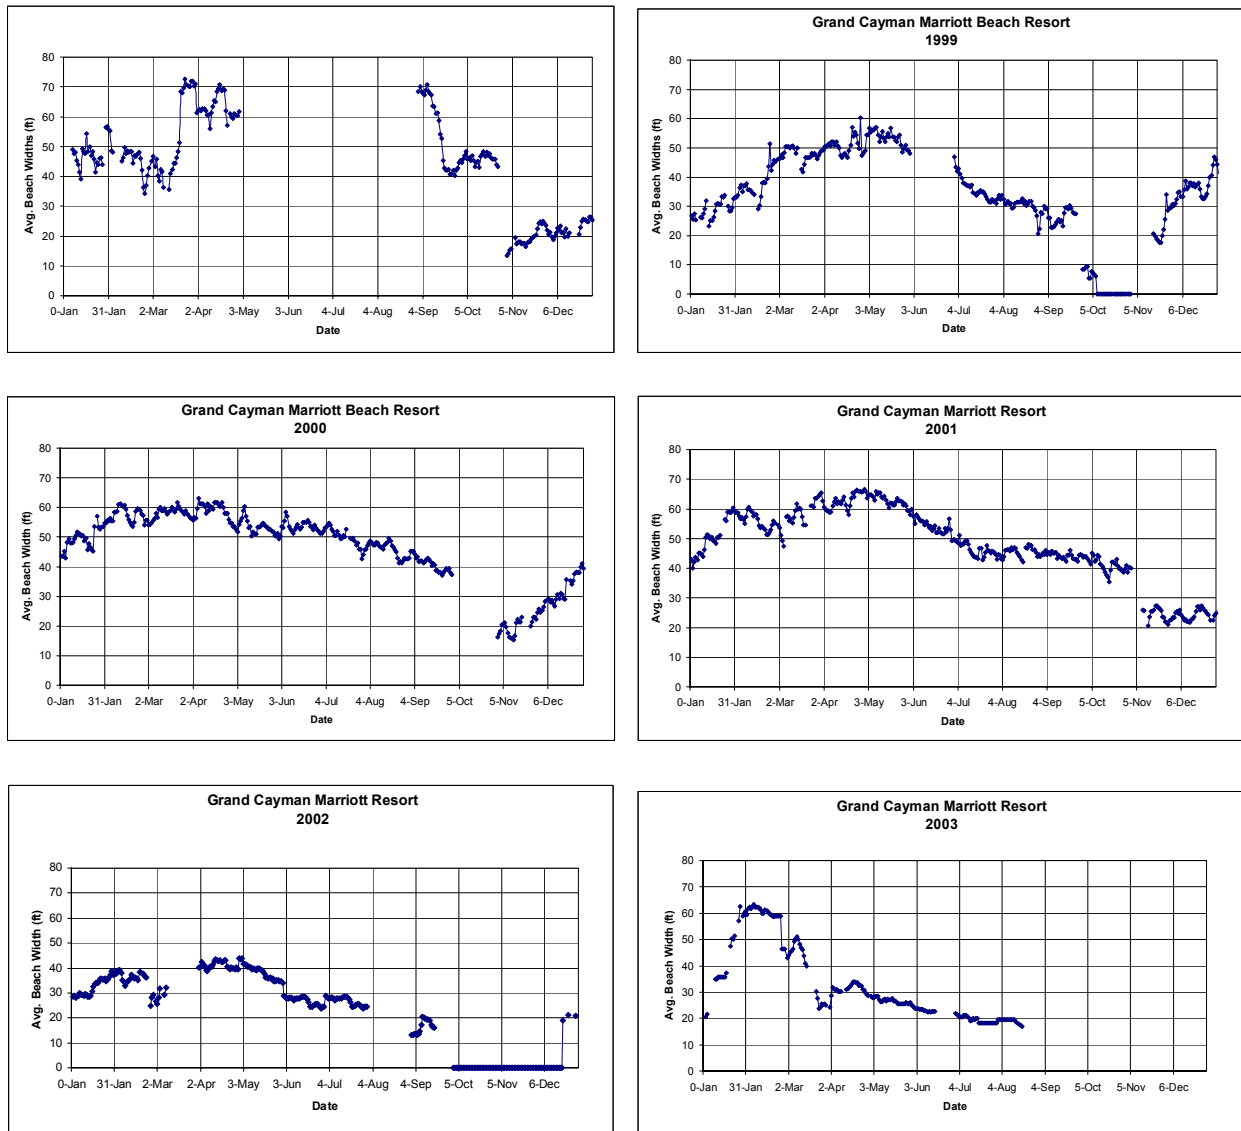
Figure 6. Beach Width Measurements taken by Marriott Staff

Note that these graphs show that there are seasonal changes in the beach width, but the beach width is continuing to decrease each year. In 2002 the maximum beach width was only 45 feet and the minimum width was zero, and the zero beach width occurred over a much greater time period than in prior years. Following the installation of the Reef Ball breakwater (completed at the end of 2002) the beach width increased to a width in excess of 60 feet, which was wider than the beach had been since June 2001 (last 2 years). Storms during the Spring 2003 reduced the beach width to 25 feet at the Marriott (and to zero on adjacent beaches to both the north and south). Further erosion of the beach has reduced the beach width at the Marriott to 19 feet. The fall tropical storm and hurricane season has the narrowest beach widths, which could reduce the existing beach width further, depending on the tropical storm and hurricane activity near Grand Cayman.

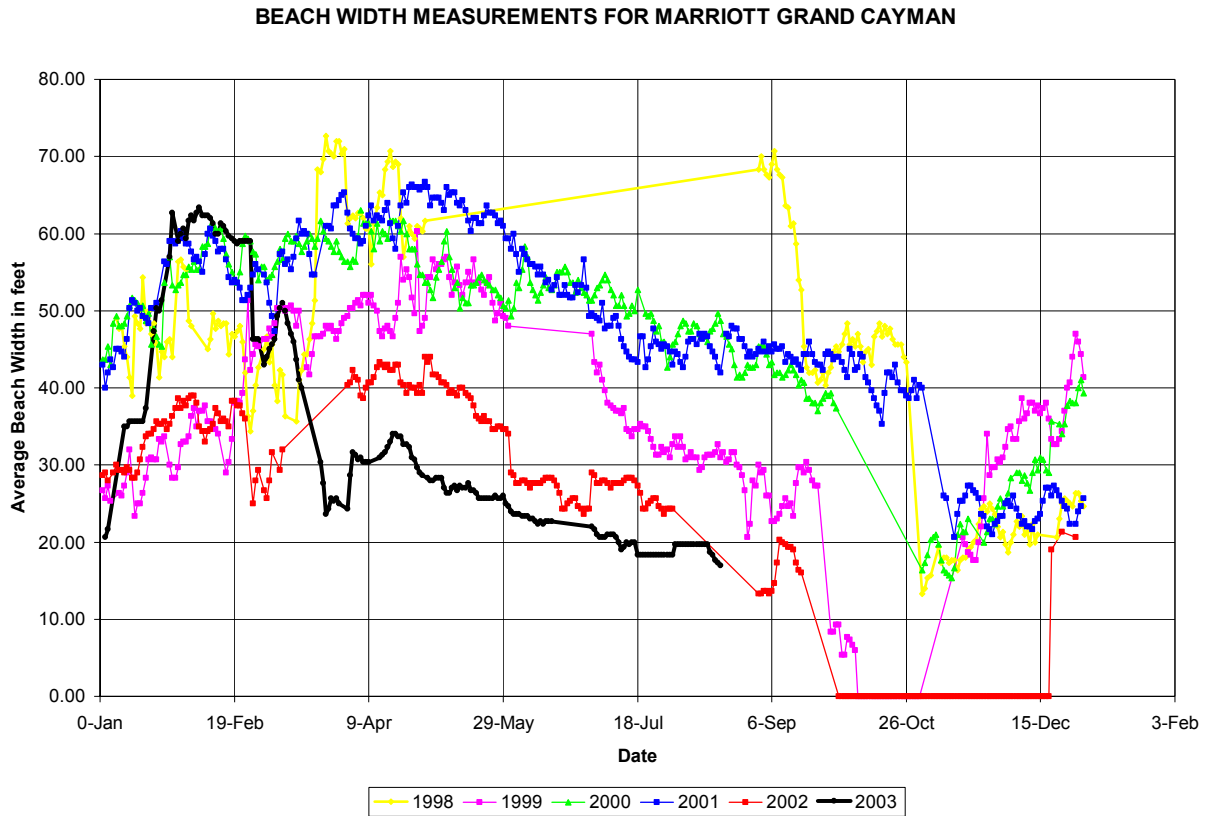
The graph in Figure 7 shows the beach width measurements for the past 6 years all on one graph, to show the variations from year to year. This graph shows the seasonal changes in beach widths and the variations from year to year depending on the variation in oceanographic conditions.

Figure 7. Beach Width Measurements showing Seasonal and Annual Variations

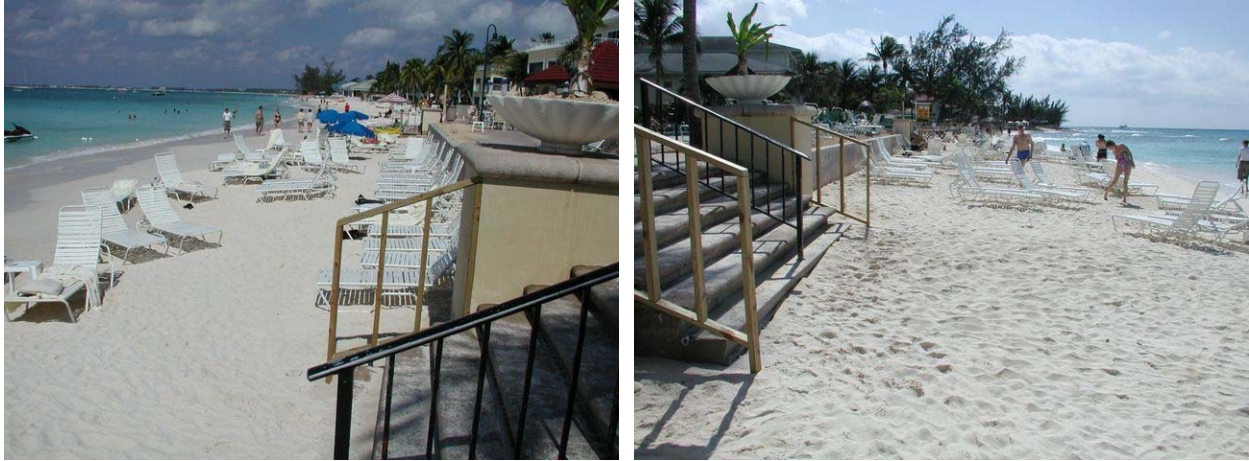
The photographs in Figure 9 taken in February 2003 show the condition of the beach, which increased in width from zero to over sixty feet wide, following the installation of the Reef Ball breakwater. Over 200 Reef Ball units were installed in the design template, with top elevations near but below the normal low tide elevation as was designed and permitted, as shown in the photographs in Figure 10 and 11.

Figure 9. Views North (left) and South (right) of the Marriott Beach in February 2003

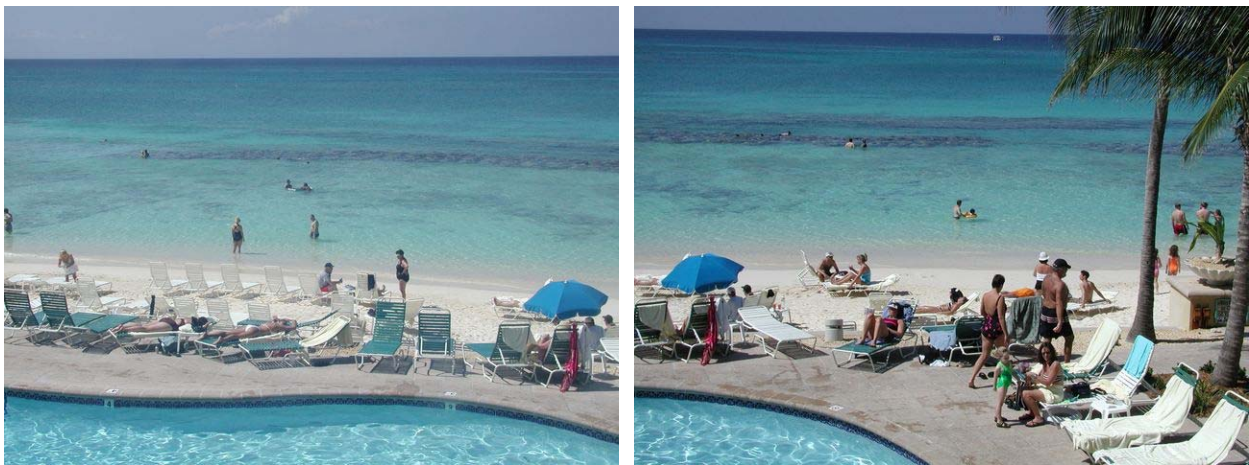
Figure 10. February 2003 Photographs showing the offshore Reef Ball Breakwater

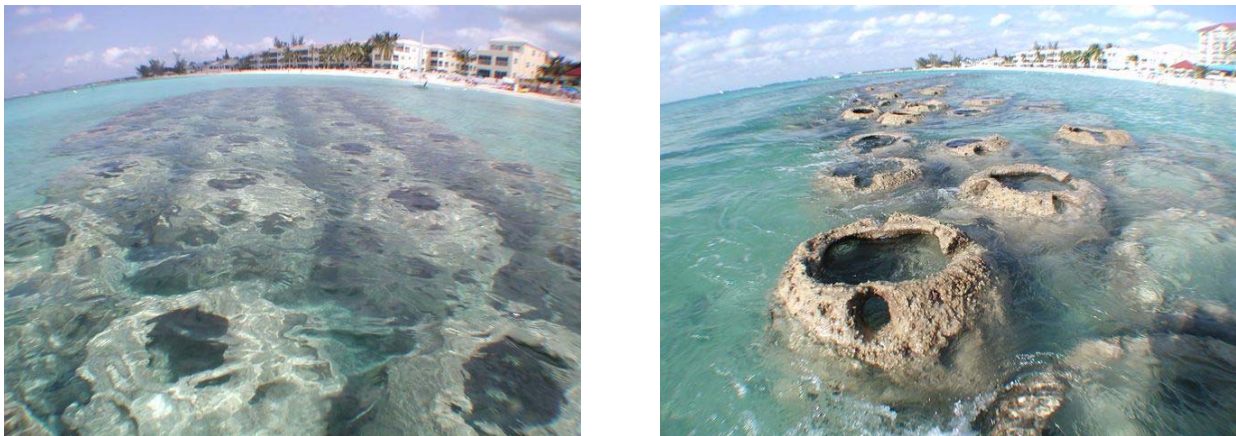
Figure 11. Northern (left) and Southern (right) Reef Ball Artificial Reef Submerged Breakwater Segments at Extreme Low Tide.

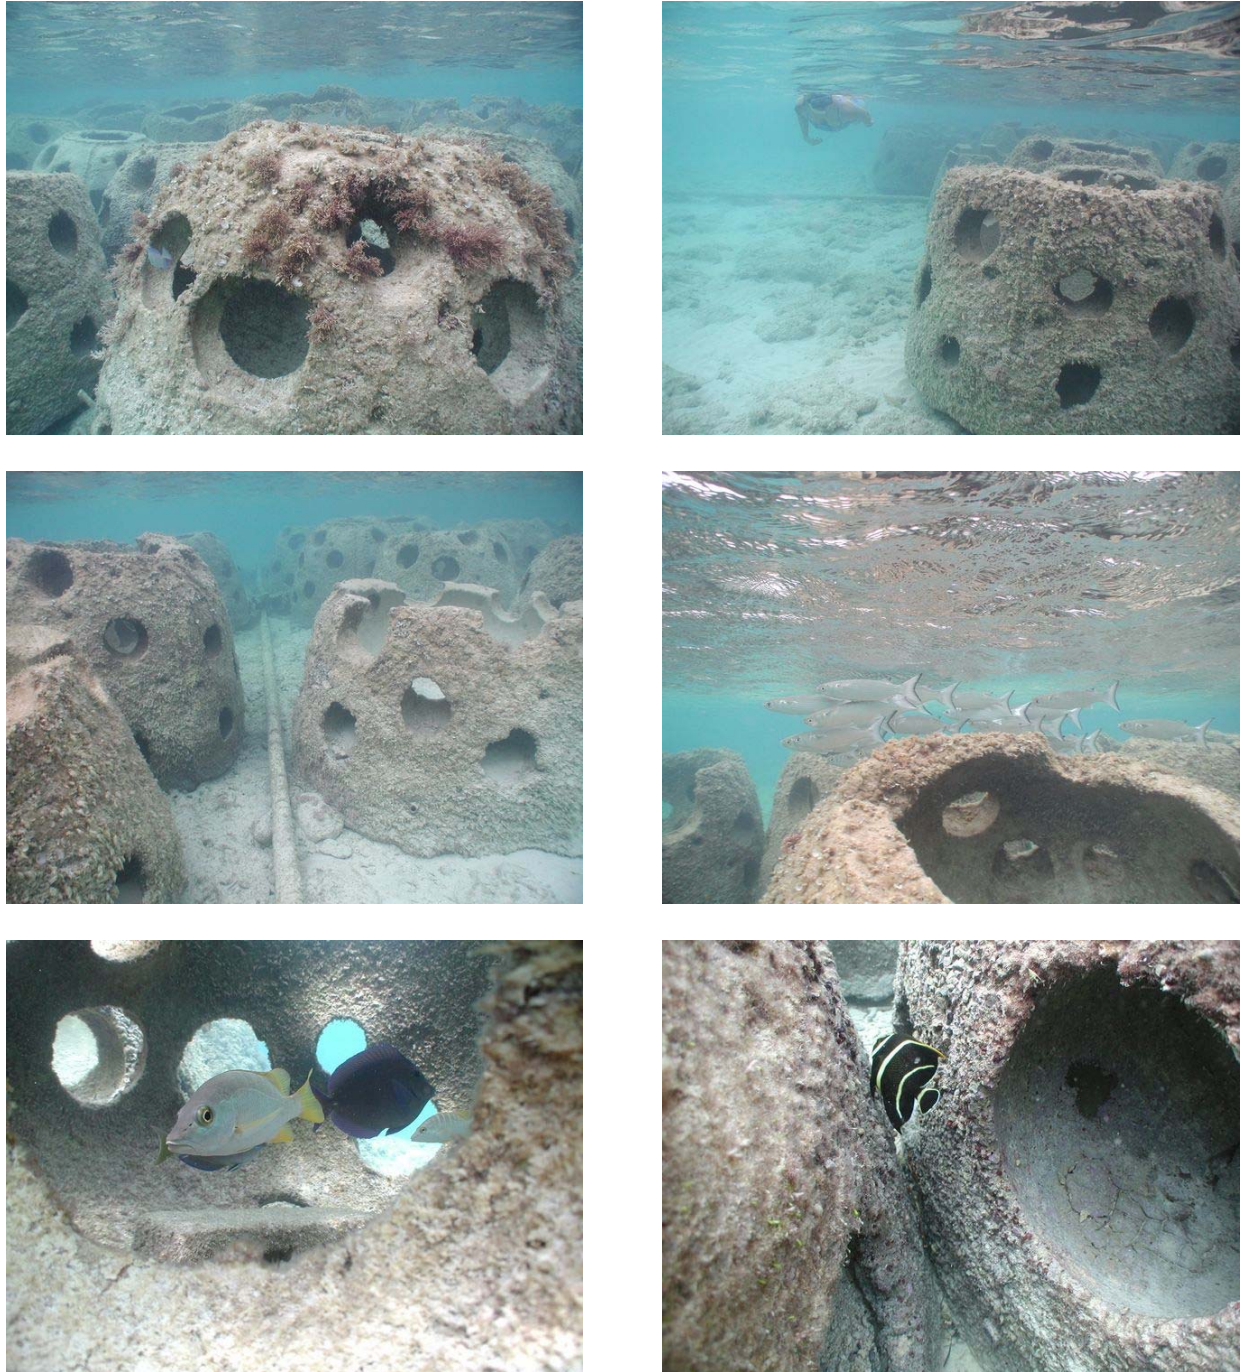
The underwater photographs in Figure 12 show the condition of the Reef Ball units. After only 3 months, there is considerable marine growth on the Reef Ball units and several species of fish in and around the artificial reef units. Note that some of the Reef Ball units had to be fabricated shorter than the standard size, due to the shallower water depths at the south end of the breakwater.

Figure 12. Underwater Photographs of Reef Ball Breakwater Units

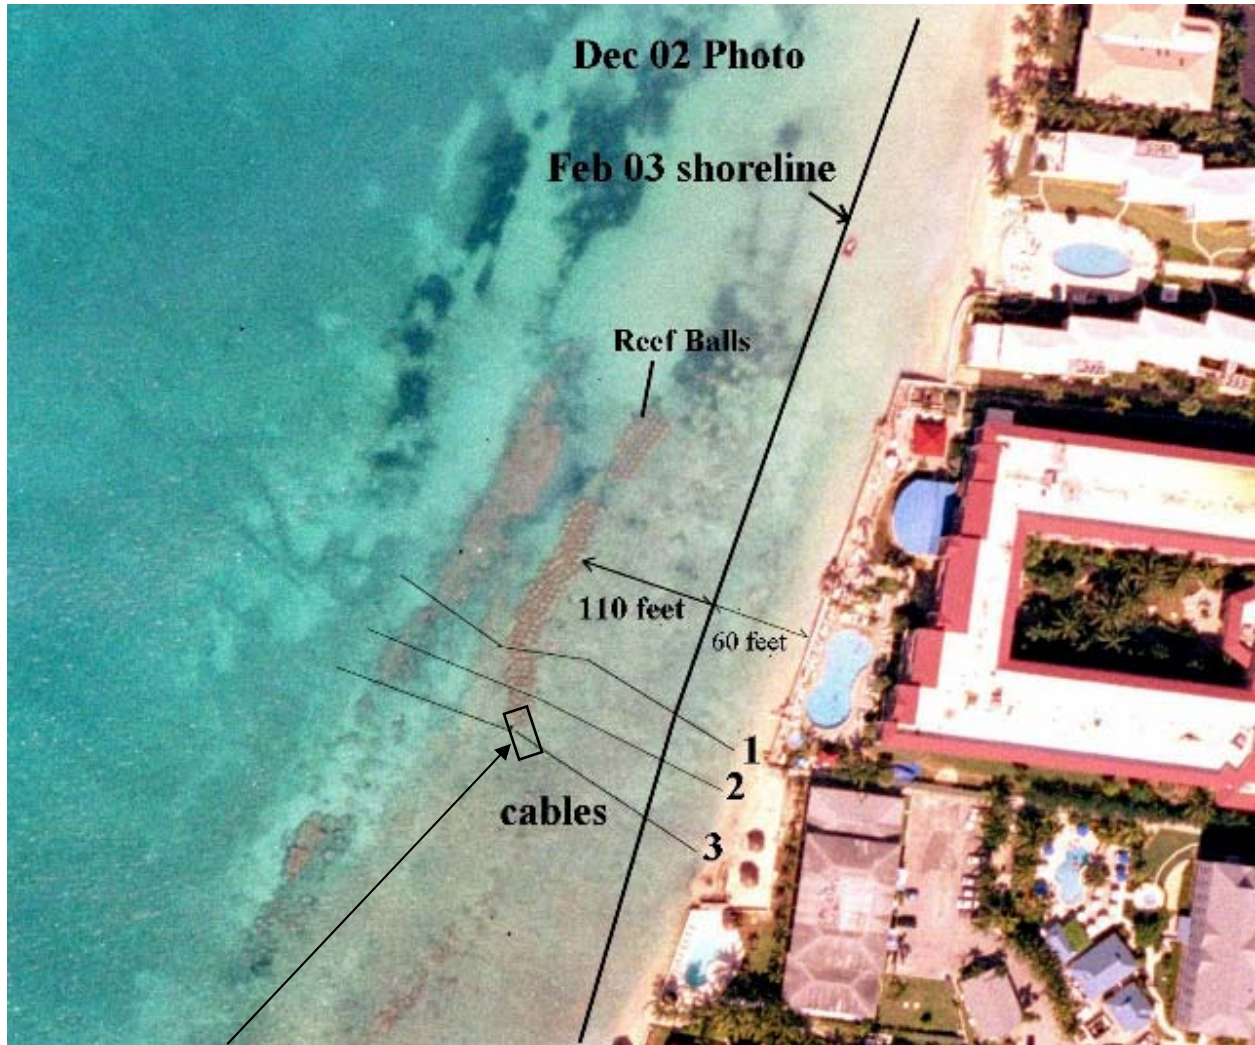
Figure 13. December 2002 Aerial Photograph showing the Completed Reef Ball Breakwater and Area for the Proposed Additional Reef Ball Units

A survey of the water depths in the vicinity of the south end of the breakwater was performed to investigate the proposed addition of 32 more Reef Ball units at the south end to increase wave protection from the SW. Special permission was required from the property owners to the south, as this extension will be located offshore of the north end of their property. The proposed extension is shown in the aerial photograph below, which would increase protection for the Marriott from waves from the southwest.

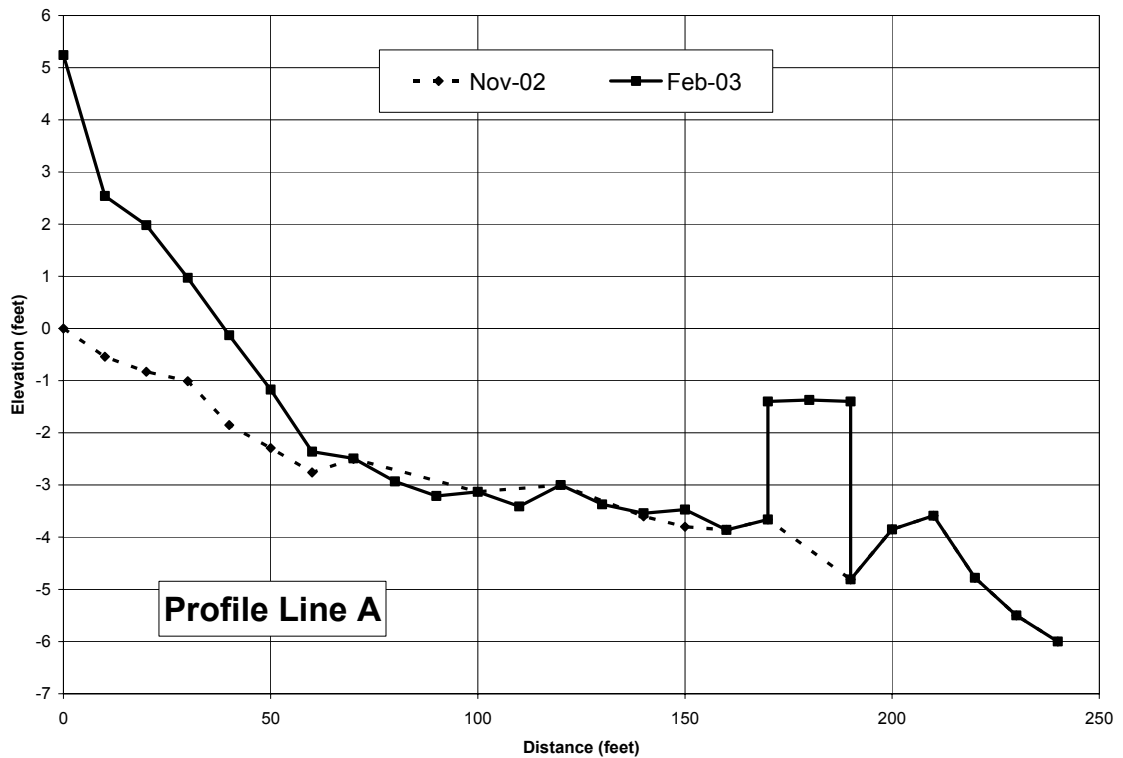
These graphs show the additional sand that accreted seaward of the Marriott seawall following the installation of the Reef Ball breakwater. The beach width increased from zero to 40 to 55 feet in width from November 2002 to February 2003, whereas the widest beach width in all of 2002 was 45 feet. Recent wave action has reduced the beach widths to an average of 19 feet at the Marriott (but even less at adjacent beaches in the area), and the current tropical storm and hurricane season may further erode the beach. However, the completed Reef Ball breakwater (and extension if added) is designed and has served to minimize the beach erosion and assist with the stabilization of the beach at the Marriott.

Figure 14. Profile Line A – Across South End of Reef Ball Breakwater

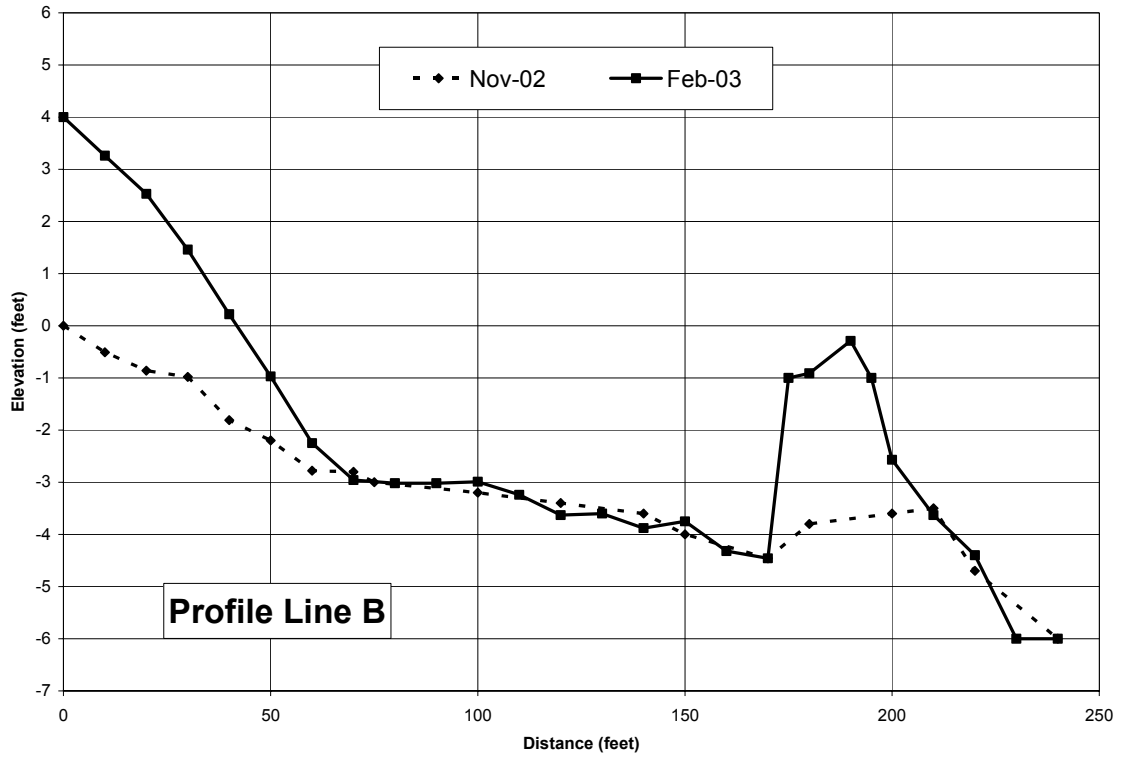
Figure 15. Profile Line B – 30 feet North of Southern End of Reef Ball Breakwater

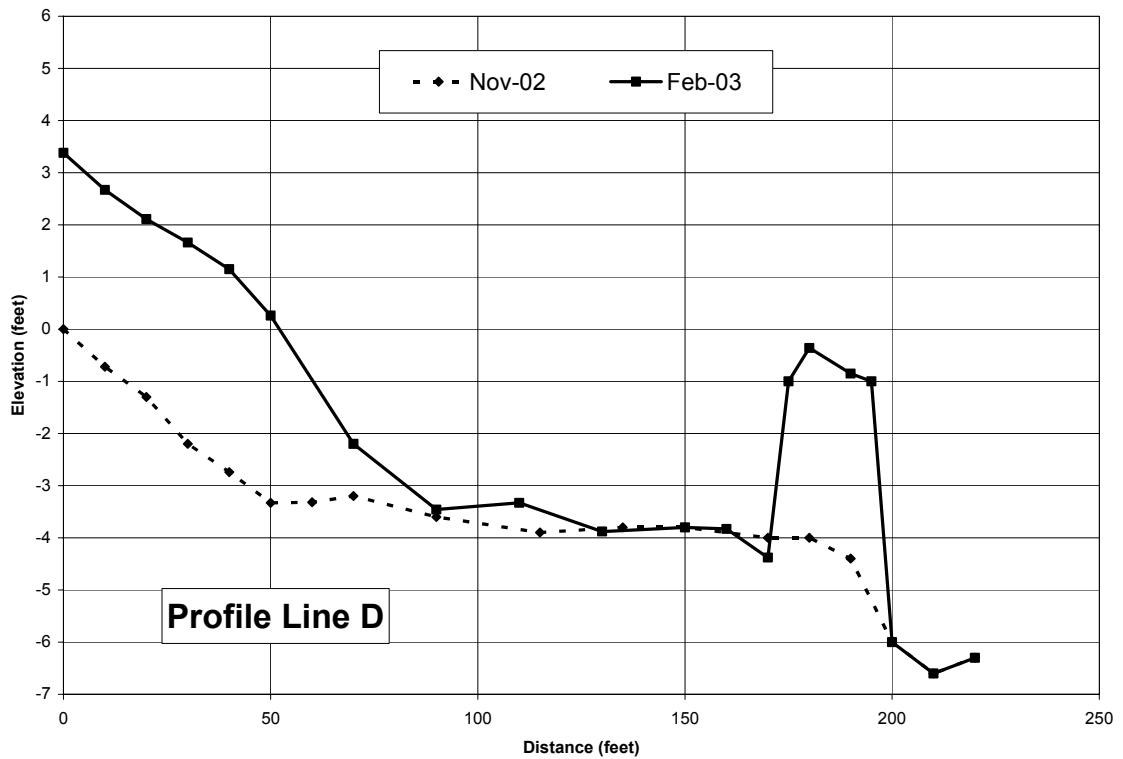
Figure 16. Profile Line D – 130 feet North of Southern End of Reef Ball Breakwater
