Designs for Artificial Reef Sites in the Indian River Lagoon Martin County, Florida

Lee E. Harris, Ph.D., P.E.
Consulting Coastal Engineer
310 Ormond Avenue
Indialantic, FL 32903

February 2002

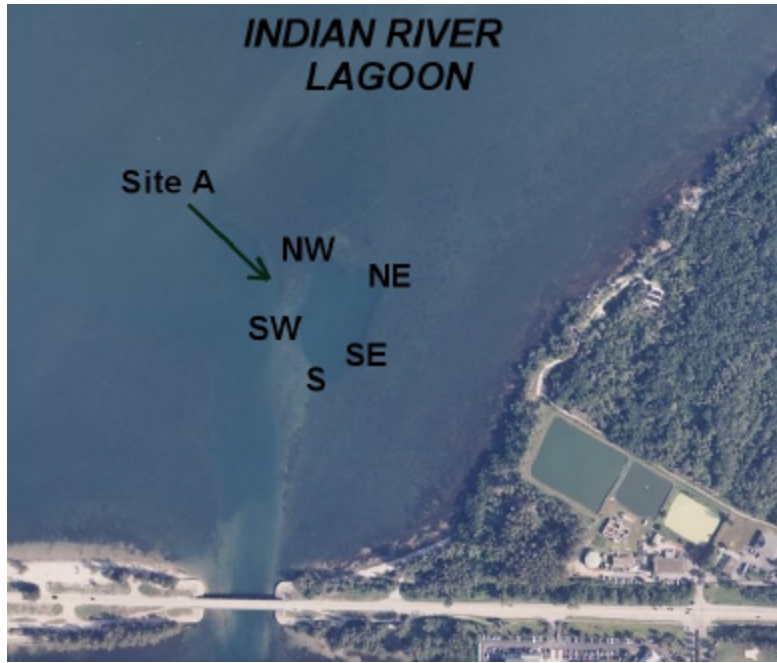
Figure 2. Site A

The southernmost site, Site A is located approximately 700 feet north and slightly east of the small eastern causeway bridge. Figure 2 shows an enlarged aerial photograph of this site, which is roughly 400 feet long by 250 feet wide. The actual shape is a pentagon, with the five vertices labeled as SW, S, SE, NE and NW. Water depths are shown in Table 1.

The water depths shown in Table 1 show that the average depth inside Site A is 12.7 feet below MLLW, with a maximum depth of 14.6 feet at the southern end.

Visual diver inspections were made for Site A on December 20, 2001 from 10am to 1pm EST. The results of these inspections are shown in Table 2. From the diver inspections, the bottom material for Site A consisted of sand and firm mud, with a maximum penetration by hand of 1.5 inches into the bottom. No seagrasses were found attached or growing on the bottom within Site A.

The southern Site A was found to be suitable for artificial reef placement. This site is approximately 400 feet long and 250 feet wide which is about 2.2 Acres, and has an average depth of over 12 feet below MLLW. No seagrasses were found growing on the bottom of Site A, and the bottom is sand and firm mud, with only 1.5-inches of penetration by hand, so that sinking of reef units into the bottom would be minimal. The adequate water depths, firm substrate, and absence of seagrasses make Site A suitable for artificial reefs.

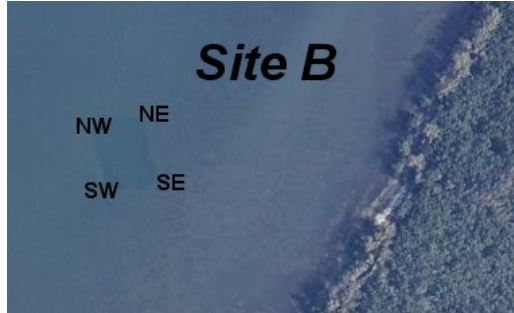
Figure 3. Site B

Site B is located approximately 1900 feet northeast of Site A , and is approximately 600 feet offshore of Hutchinson Island. Figure 3 shows an enlarged aerial photograph of this site, which is roughly 200 feet long by 150 feet wide. The shape is nearly a rectangle, with the four vertices labeled as SW, SE, NE and NW. Water depths are shown in Table 3.

The water depths shown in Table 3 show that the average depth inside Site B is 11.7 feet below MLLW, with a minimum depth of 11.2 feet in the NW and maximum depth of 12.4 feet in the center.

Visual diver inspections were made for Site B on December 20, 2001 from 2pm to 4pm EST. The results of these inspections are shown in Table 4. From the diver inspections, the bottom material for Site BA consisted of soft mud, with a penetration by hand of at least 30 inches into the bottom. No seagrasses were found attached or growing on the bottom within Site B, but the soft mud does not provide a firm foundation to support artificial reef units.

From the diver surveys of the two sites at the east end of the Stuart Causeway in the Indian River lagoon, the southern Site A was found suitable for artificial reefs, but the northern Site B was found unsuitable. Site B has sufficient depths, but the soft mud bottom with 30 inches and more of penetration into the bottom by hand would not provide support for artificial reef units.

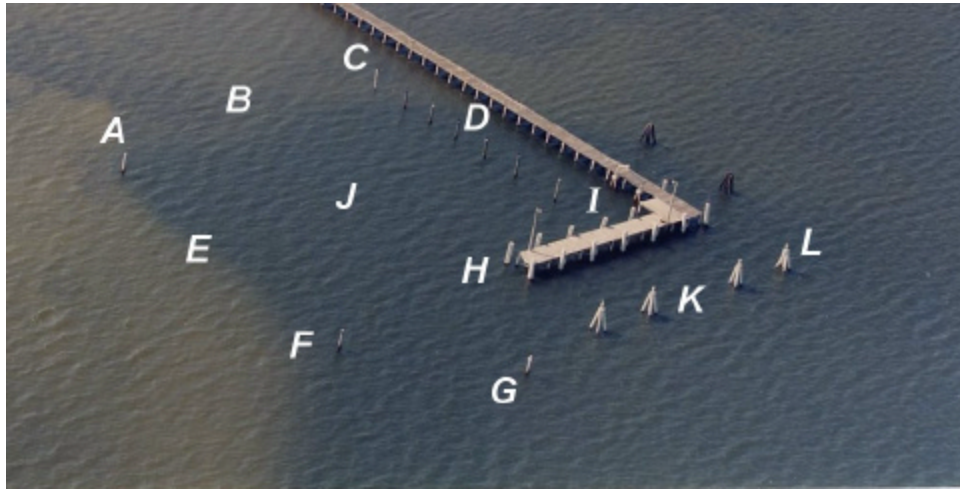
Figure 5. Designation of Points for Survey of Pier at Indian Riverside Park

A close-up of the pier and surrounding area surveyed for possible artificial reef sites is shown in Figure 5, with the letters designating the locations of the depth measurements and diver inspections performed on January 11, 2002.

There are some areas in the vicinity of the Indian Riverside Pier that are suitable for artificial reef deployment. Floating docks are planned for the dredged basin south of the pier, so this area is not available for artificial reefs. The area immediately under the pier is suitable for artificial reefs over the eastern end and "L" portion where the depths are 5 to 9 feet below MLLW. The areas to the north and east of the pier are too shallow for artificial reefs, unless boat traffic is excluded from that area.
