Oyster Growth and Survival on an Artificial Reef in New Haven Harbor

Chloe Chmelar¹, Peter Solomon¹, and Hayley Lemoine²

¹The Sound School, New Haven CT; ²Yale University, New Haven CT

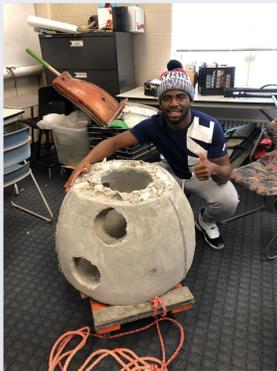
Figure 1: Each Mini-Bay Ball RBM weighs 90kg and provides 2.9m² of surface area and was constructed using materials and guidelines provided by the Reef Ball Foundation.

Students and faculty at the Sound School built five Mini-Bay RBM's (width: 0.76m, height: 0.53m, weight: 91kg) using oyster shells as a cement additive (see Figure 1). In May of 2018 the aquaculture laboratory at the school successfully spawned oysters, *Crassostrea virginica*. After the spawn three RBM's were placed in a set-tank with 200 micron spat. The RBM's soaked for ten days. In June 2018 the RBM's, three with set and two unseeded, were deployed in nearshore waters by the school campus for the creation of an artificial oyster reef (see Figure 3).

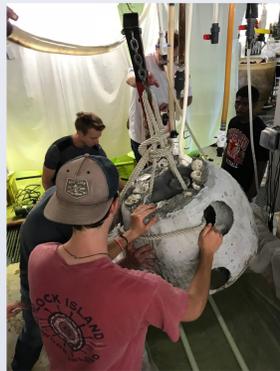
Figure 2: 3 RBM's were placed in a set tank, conditioned, and inoculated with larvae for 10 days. Oyster spat successfully set on the exterior, interior and within the holes in each RBM creating nearly complete coverage.

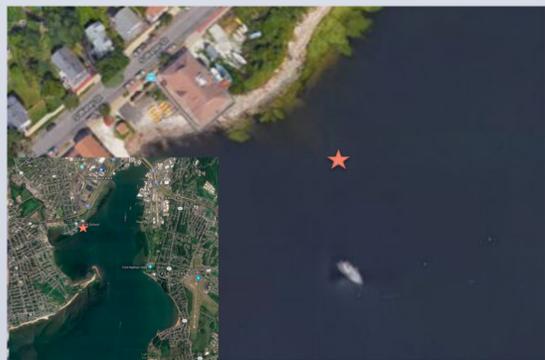
Figure 3: Current location of RBM's, approximately 40m offshore. This spot was selected to avoid creating any additional navigational hazards, accessibility, and firmness of the substrate.

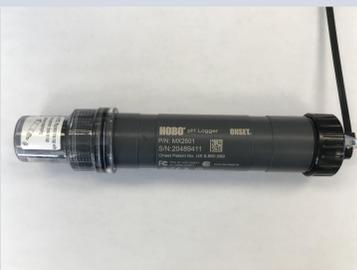
Figure 9: HOBO MX2501 pH and Temperature logger by Onset was placed on the RBM on 3/21/19 and picked up on 3/28/19. The logger collected data in 15 minute intervals for one week.

During the trial on March 21, a HOBO MX2501 pH and Temperature logger was attached to RBM 2 with zip ties to record data over the course of the next week (see Figure 9). The successful deployment and recovery of the logger will guide future monitoring efforts that will seek to pair environmental data with growth, mortality, spawning, and recruitment.

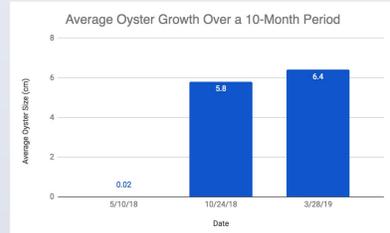
Figure 11: Average oyster growth measured over 3 dives from May 2018 to March 2019. Averages for oyster length were taken from measurements across all three RBM's.

Method 2 was tested again on 3/28/19. The weather for the week had been very mild so visibility was very good. Because of the previous week and the difficulty the divers had when trying to stay still, PVC poles were added to provide an anchor point for the divers to improve stability. Length and mortality data was successfully collected on all three RBM's. However, mortality data proved to be insufficient since scarring from oysters that had been lost or detached from the structures were not quantified.

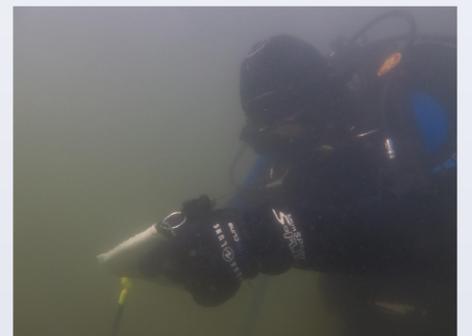
Figure 15: Picture taken on 3/28/19 of diver employing Method 2 to record lengths of oysters on RBM1.

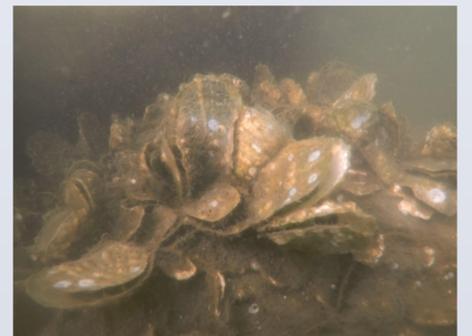
Figure 16: Gaping oysters as seen above were counted as dead. These oysters also have scarring from *Urosalpinx cinerea* predation.

Divers observed oysters had higher survival rates when on more sheltered aspects of the RBM's including sides facing the interior of the ring and in the holes in the structure. Mortality rate for the exterior of the RBM's exceeded 50% on all modules. RBM1, the most sheltered structure, demonstrated highest survival rate with the most uniform coverage. There was extensive algae growth on the unseeded RBM's recorded in the fall dives and in the recent spring dives. RBM5 was documented to have the most algae growth on and around living oysters. RBM's facing the sound, only had algae growth along the base. Divers also noticed scarring from oysters that had grown and fallen off the RBM's as well as living oysters resting in the sediment that had detached from structures. During these three trials divers also observed the following species on the reef: *Callinectes sapidus*, *Hemigrapsus sanguineus*, *Urosalpinx cinerea*, *Tautoga onitis*, *Libinia emarginata*, *Busycotopus cancellatus*.
