Investigations and Recommendations for Solutions to the Beach Erosion Problems in the City of Herzliya, Israel

Site Inspection Performed 30 April to 6 May 2007

Lee E. Harris, Ph.D., P.E.
Consulting Coastal & Oceanographic Engineer
Assoc. Professor of Ocean Engineering
Department of Marine & Environmental Systems
Florida Institute of Technology
Melbourne, Florida 32901 USA

October 2007

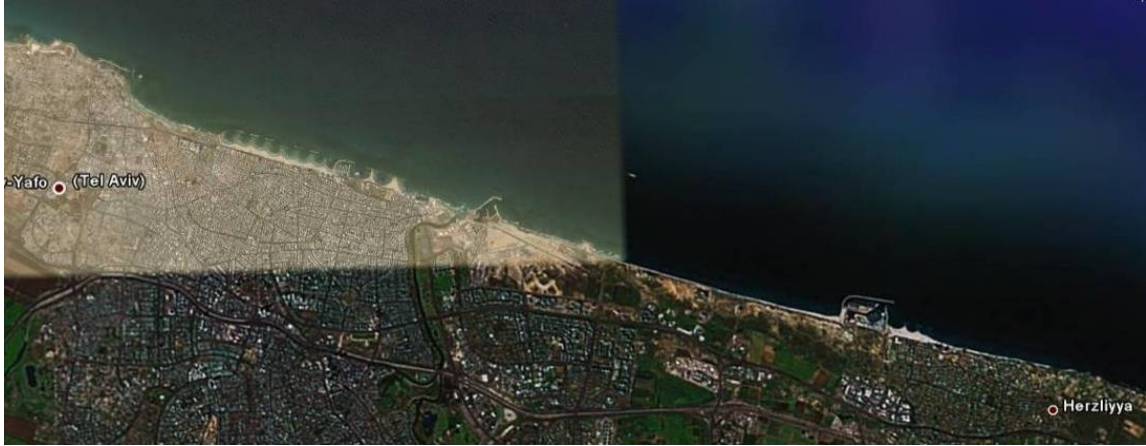
Figure 2. Coastline from Tel Aviv to Herzliya
Predominant littoral sand transport is from S to N (left to right).

Herzliya is located on the west coast of Israel in the Mediterranean Sea, as shown in Figure 1. Due to the large fetch to the west, the area is subject to large waves from the NW, W, and SW directions. Predominant alongshore current and littoral sand transport is from south to north, with sand sources reported as from far away as the Nile River Delta. Numerous coastal structures have been constructed along the Israeli coast, including port and harbor facilities, marinas, and emergent (subaerial) segmented breakwaters. Many examples of these coastal structures are located in Tel Aviv, south of Herzliya, as shown in Figure 2.

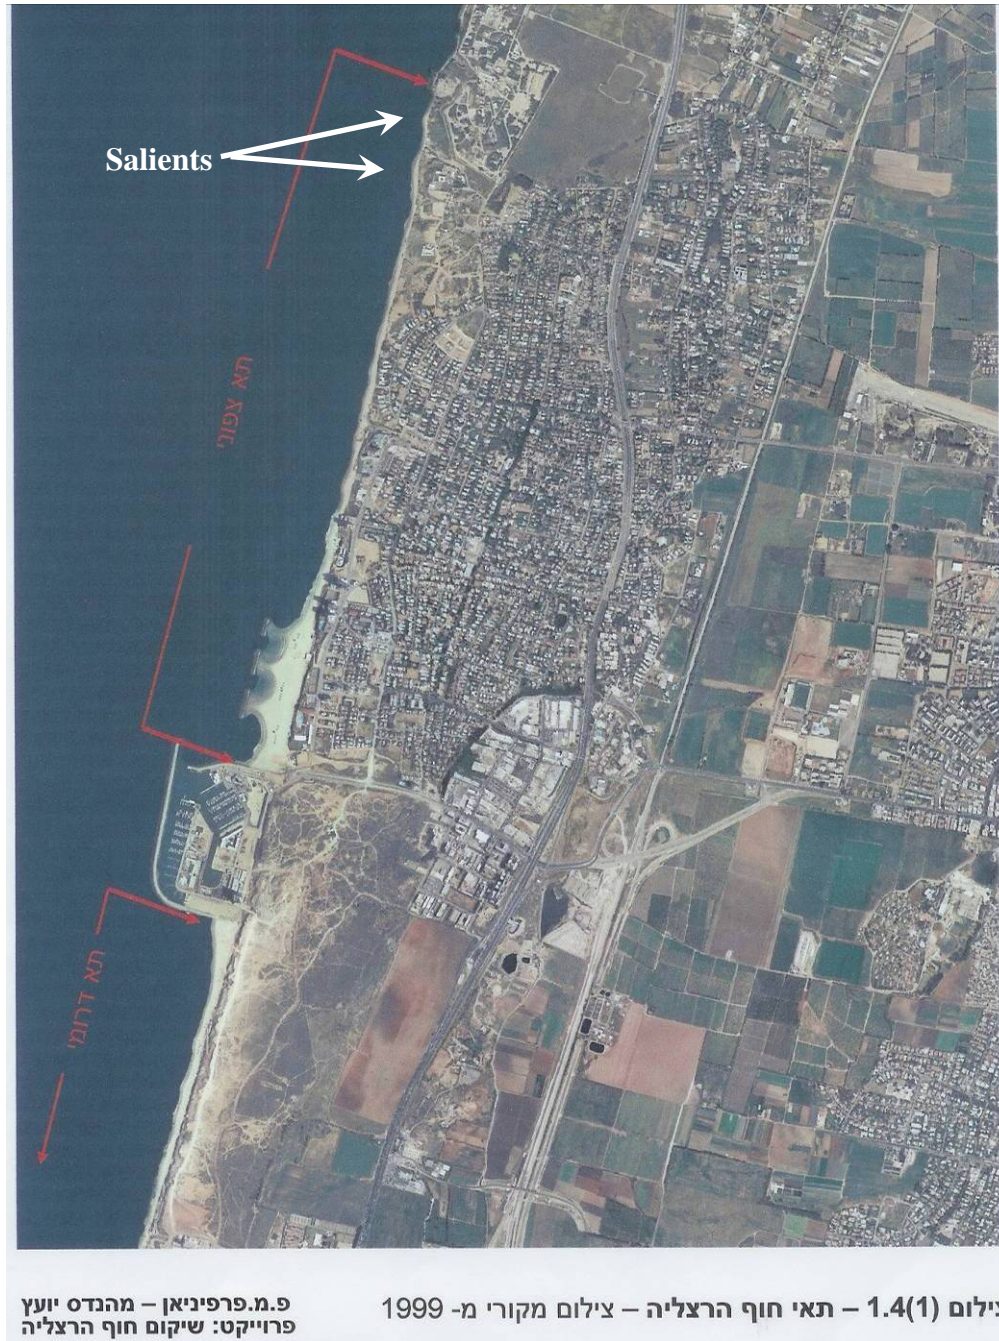
Figure 3 shows an aerial photograph of the City of Herzliya coastline, where the dominant features are the marina and segmented breakwaters immediately to the north (also evident in Figure 2). The three breakwaters were constructed to prevent the anticipated erosion downdrift of the marina, with natural sand accretion in their lee (they were not pre-filled with sand after construction). The widest beaches are found in the lee of the breakwaters, and south (updrift) of the marina.

Figure 3. Project Study Area showing the zones North and South of the Marina

The beach is very narrow north of the breakwaters, due to the blockage of longshore sand transport by the marina, and the trapping of sand by the breakwaters. However, there are two salients with wider beaches, indicated in Figure 3, and in the photograph shown in Figure 4. These salients are formed due to the naturally occurring offshore reefs, visible in the photograph, that act as submerged breakwaters.

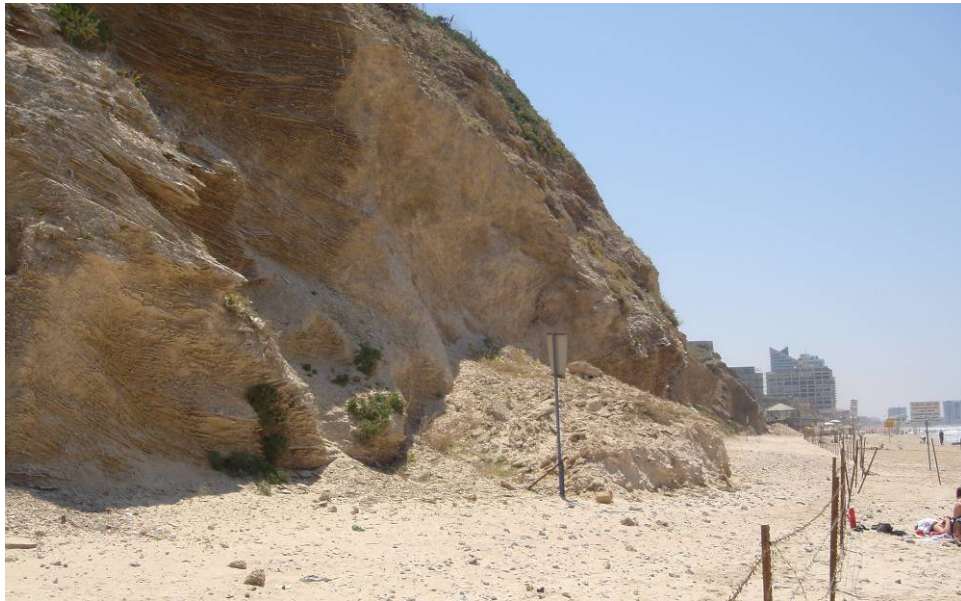
Figure 5. View of cliff erosion North of the Marina – 1 May 2007 Photograph

Previous papers, reports and studies document the effects of the marina and breakwaters on the beaches to their north (downdrift). Erosion of those beaches has led to increased erosion of the cliffs, and several areas where this has occurred are visible along the Herzliya coast, with one example shown in Figure 5.

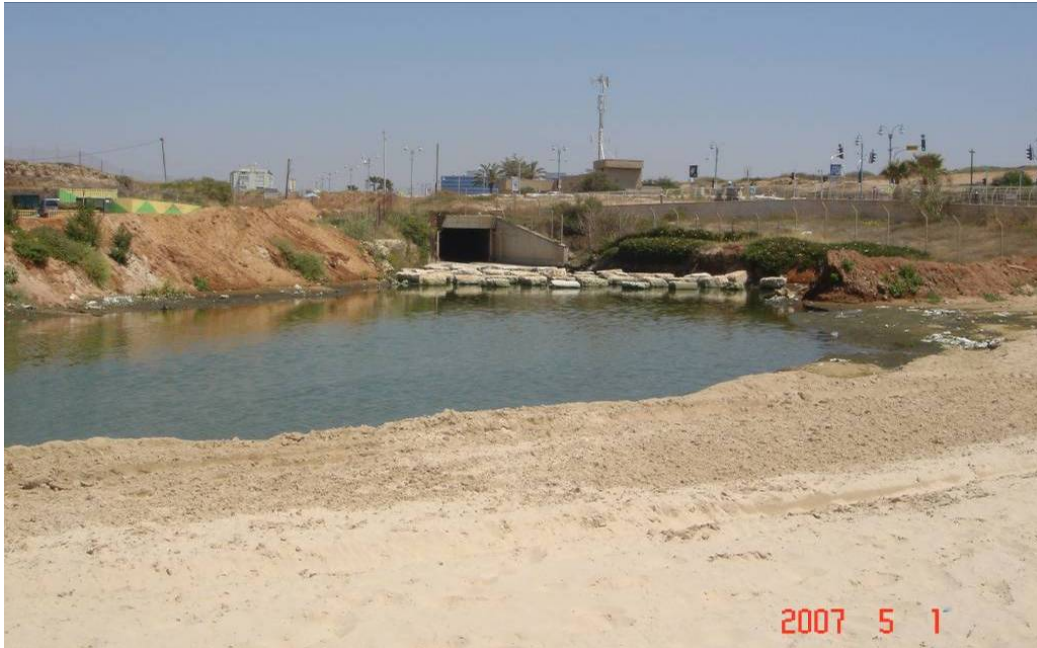
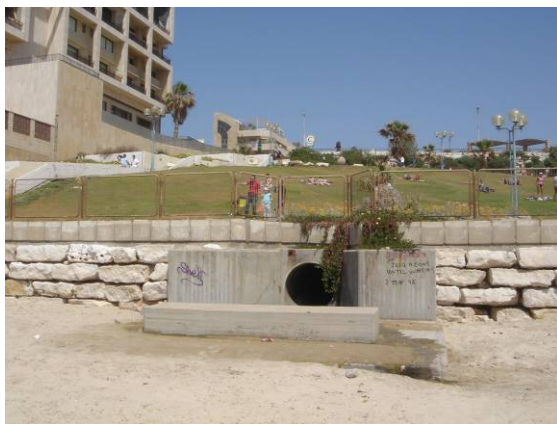
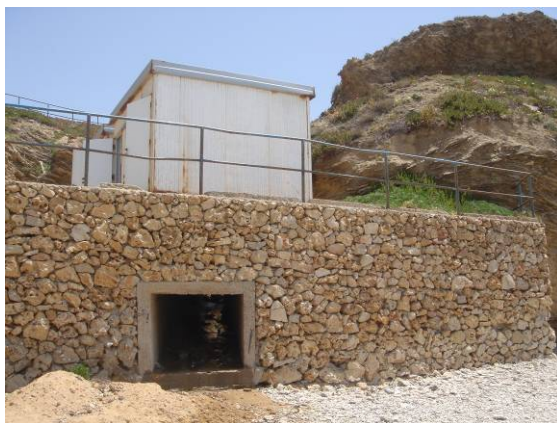
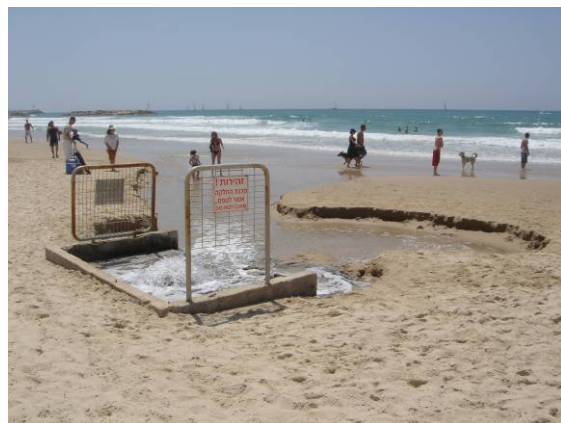
4. there are outfalls for storm water that empty directly onto the beach, with examples of these in Figure 8. The largest of these is the outfall immediately north of the marina, which is at the end of a drainage canal (top photograph in figure 8). All of these outfalls have the potential to wash sand from the beach, especially during large rainfalls. There is also a discharge for a water-cooled air conditioning system shown in Figure 8 (last photograph), and although minor, shows water flowing out, washing sand offshore and eroding a channel in the beach.

Figure 8. Various Outfalls along the Herzliya coast

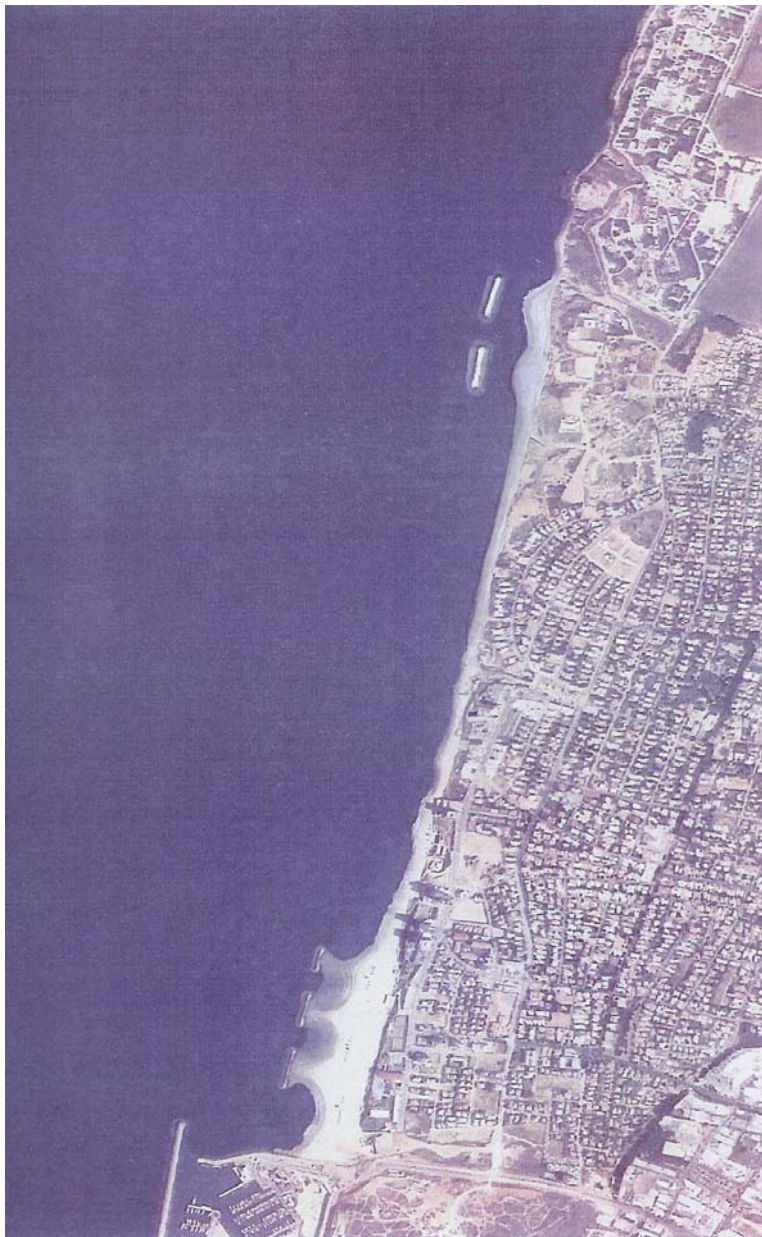
Another alternative would be to add one or more breakwaters to the north end of the Herzliya area, as shown in Figure 9. The salients or tombolos formed in the lee of those northern breakwaters could assist in stabilizing the beaches to their south. Pre-filling of the breakwaters is recommended, so that initial accretion in the lee of the breakwaters with the formation of the salients or tombolos does not rob sand from surrounding beach

Figure 9. Proposed Breakwaters at the North end of Herzliya

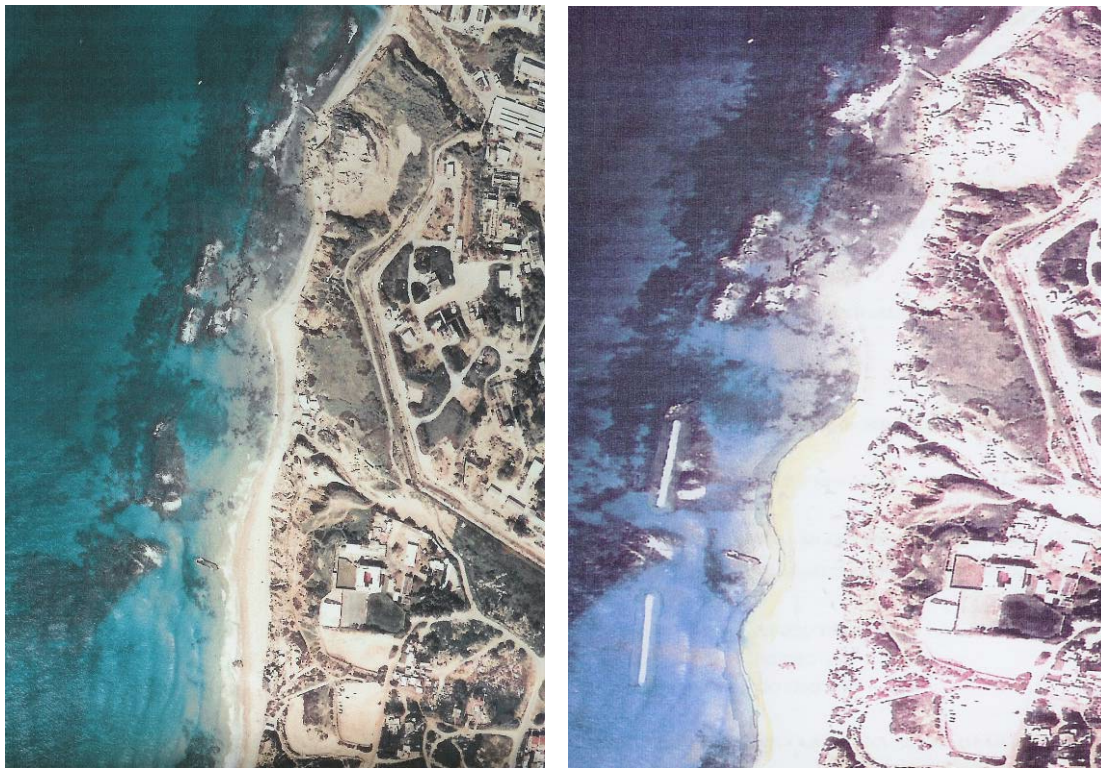
The left aerial photograph in Figure 10 shows the existing northern Herzliya coastal area, with naturally occurring offshore submerged reefs and salients that form naturally in their lee. The right photograph in Figure 10 is the same area, with a conceptual layout of two proposed submerged breakwaters and the formation of two additional salients in their lee. These breakwaters could be designed and constructed as submerged artificial reefs, to enhance the marine habitat provided by the natural reefs in this area, as well as to assist with shoreline stabilization.

Figure 10. North End of Herzliya Beach (Apollonia at the top)

The left photograph shows the existing offshore submerged reefs with salients that have formed naturally along the coast. The right photograph shows a conceptual layout of two offshore submerged artificial reefs, and the salients that would form in their lee.

Construction of two submerged breakwaters offshore of the northern Herzliya beaches as shown in Figure 10 would stabilize the shoreline in that area, with beneficial effects to the south of the structures. It is HIGHLY recommended to pre-fill the beach landward of the breakwaters, with the volume of sand that is predicted to accrete and form salients in that area (determined from numerical modeling). Additional sand also can be placed along the beaches south of the new submerged breakwaters.

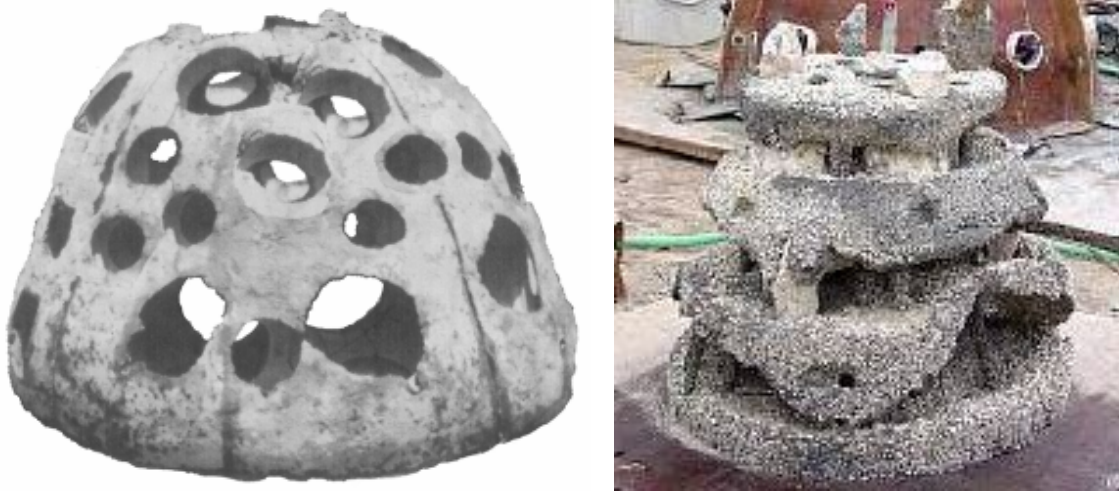
One of the designed reef units that have been used to construct submerged breakwaters is the Reef Ball™ reef unit, shown in Figure 11 with one variation of this reef unit known as the “Layer Cake” also shown. Detailed information on this reef unit and its use and performance in submerged breakwaters was provided in the preliminary report, which is included as an annex to this report. Some of the most important aspects relative to the Herzliya project are discussed in this section.

Figure 11. Traditional Reef Ball™ Unit (L) and “Layer Cake” Reef Ball Unit (R)

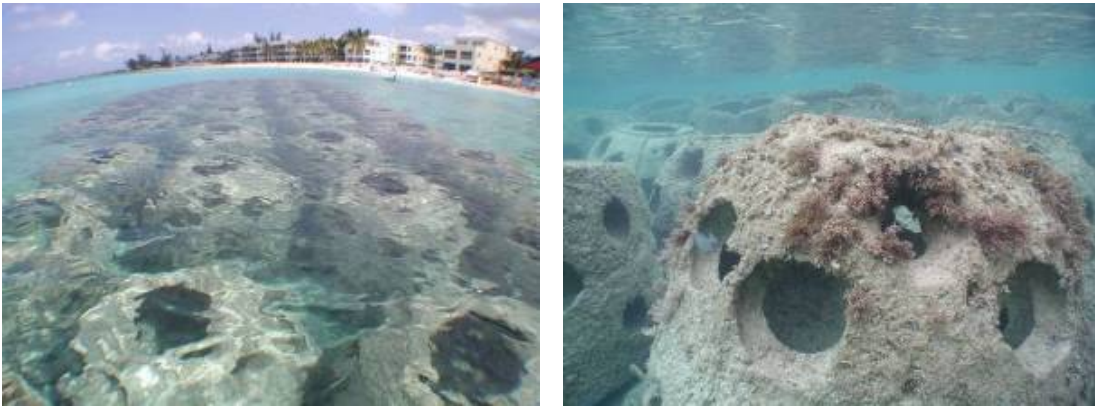
An existing Reef Ball submerged breakwaters that is similar to what is recommended for the northern Herzliya beaches is the 5-row submerged Reef Ball breakwater shown in Figure 13. This breakwater was constructed in 2002, and is located offshore of the Marriott Beach Resort at the south end of Seven Mile Beach on Grand Cayman Island. The before and after photographs shown in Figures 14 - 15 show the successful beach stabilization, even after Category 5 Hurricane Ivan impacted the area in 2005. Seasonal fluctuations in the beach width still occur, as does beach erosion from storm events, but the breakwater has effectively reduced the erosion and assisted with the stabilization of the beach.

Figure 13. Above and Underwater Photographs of the Reef Ball Breakwater
Submerged Breakwater offshore of the Grand Cayman Marriott Beach Resort

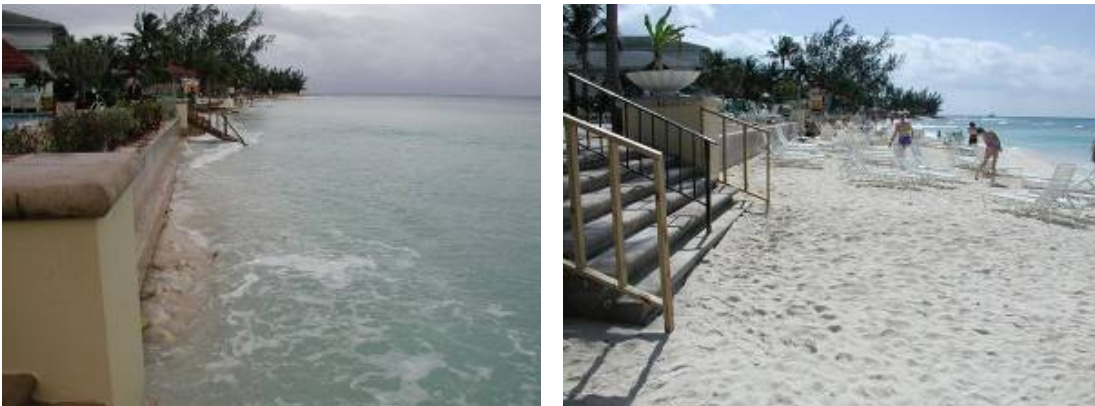
Figure 14. Marriott Beach Before and After Reef Ball Breakwater Installation
Photo from Fall 2002 (L) and February 2003 (R) after the breakwater installation

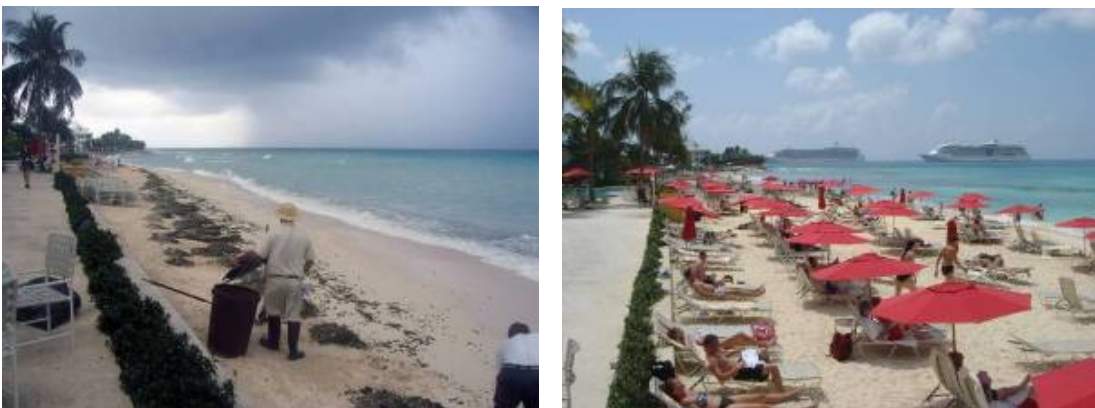
Figure 15. Grand Cayman Marriott - November 2006 (L) and February 2007 (R)
