RAPID RELOCATION OF NEARSHORE CORALS OUT OF A DREDGE ZONE SAUDI ARABIA

David Lennon (Reef Ball Australia)¹, John Walch (President, Reef Ball Coral Division)²

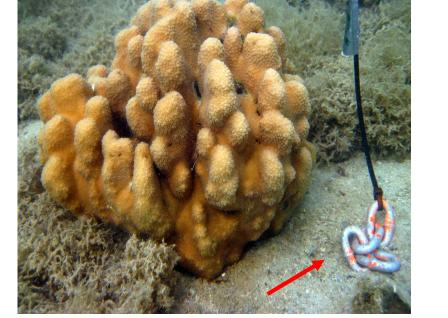
Example of typical coral head before removal and the tagging system used to track and monitor survival.

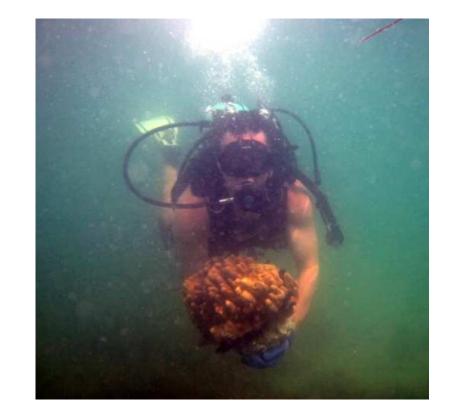
Corals were removed using prybars and chisels, placed in modified crates and carried to a staging area.

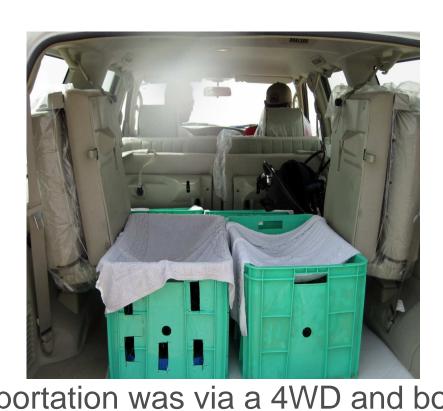
Transportation was via a 4WD and boat or underwater using lift bags. Corals were kept covered by wet towels. Max time out of water was 8 minutes.

Air temp 40 to 43C, water temp 30 to 33C

Keeping the crates covered with wet white towels proved effective.

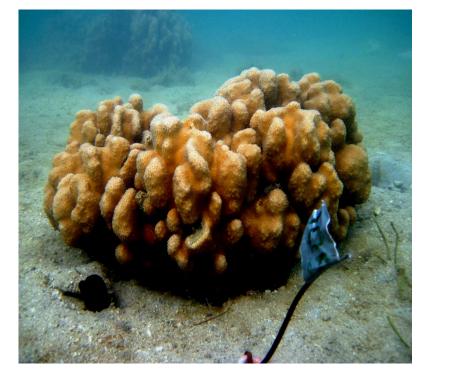
Example of replanted coral in the receiving area 700m west of dredge site. A number of the largest coral heads were spaced between the dredge site and receiving area to create a corridor. At 60 days, all corals appeared healthy and showed no to only minor signs of stress from the relocation despite high summer temperatures.
