SITE INVESTIGATIONS OF THE BEACH EROSION PROBLEM AT MAHO BEACH, ST. MAARTEN

Performed February 2003

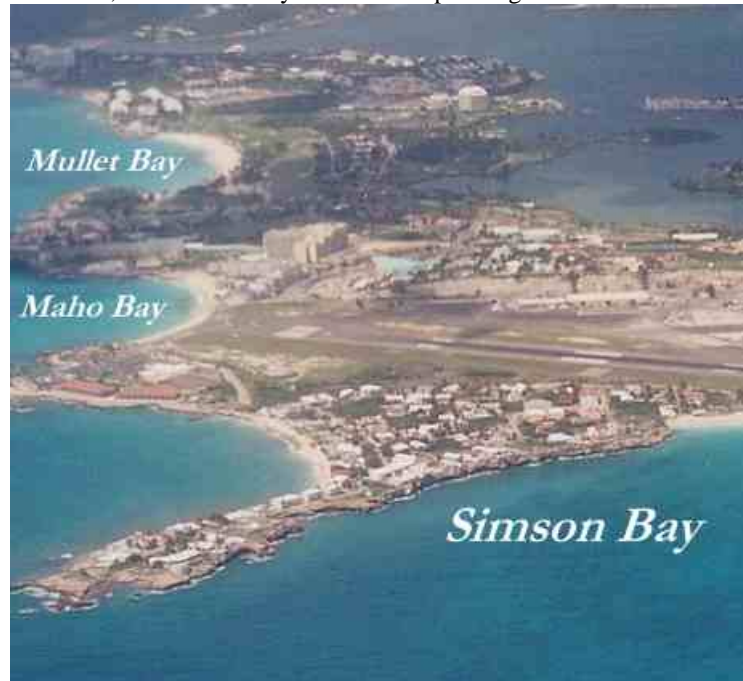
Figure 1. Oblique aerial photograph of Maho bay area.

The aerial photograph in Figure 1 shows the location of the four adjacent pocket beaches within the embayments known as (from north to south) Mullet Bay, Maho Bay, Beacon Hill cove, and Simson Bay. Sand transport between these pocket beaches would be difficult, due to the rocky headlands separating them.

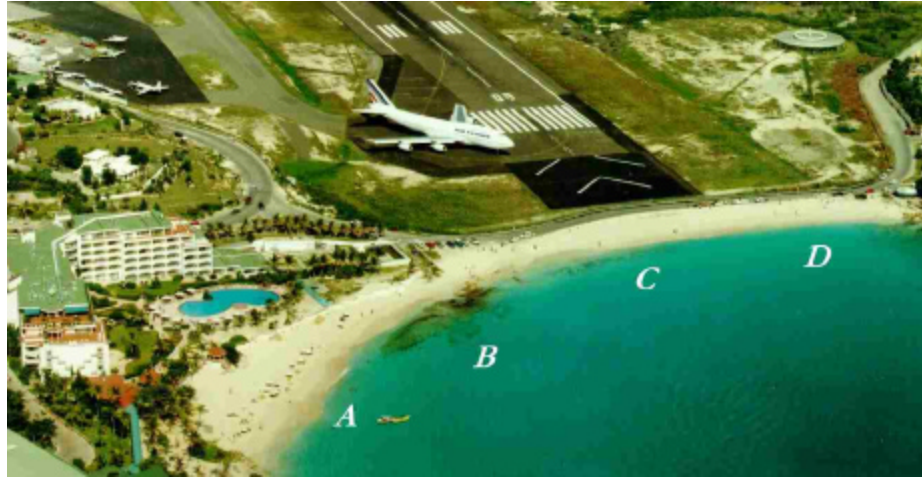
Figure 2. Four beach zones of Maho Beach (photo date unknown).

Inspection of Maho Beach during this site visit revealed a beach that can be divided into four reaches as shown in Figure 2 (photo date unknown):

- A. beach at the north end (Maho Beach hotel),
- B. rock outcrop (south end of hotel),
- C. beach at end of the runway, and
- D. beach at the south end.

During this site inspection the beach at the north end (Reach A) was the widest and flattest, and had a steep foreshore slope with relatively large waves (estimated at 1m wave height and 8-second wave period) breaking directly on the shore. The beach narrowed going south, with little sand between the exposed rock outcrop and the south end of the hotel seawall in Reach B. There is a rock revetment and wall along reaches C and D, as shown without the sand cover in Figure 3. During this site inspection there were exposed rock revetment at the north end of Reach C, with sand

covering the rocks until the south end of Reach D. Wind gusts from airplanes taking off creates a slightly lowered beach berm elevation at Reach C. In Reach D, the berm elevation was quite high, and a vertical escarpment varying from 6 to 8 feet high separated the upper flat beach from the water. Local winds blow this higher elevated sand onto the road, which must be removed to enable vehicles to use the road.

1. The beach sand that blows from Maho Beach onto the road should be returned to the beach and should not be removed from the area, otherwise this practice would contribute to the beach erosion.

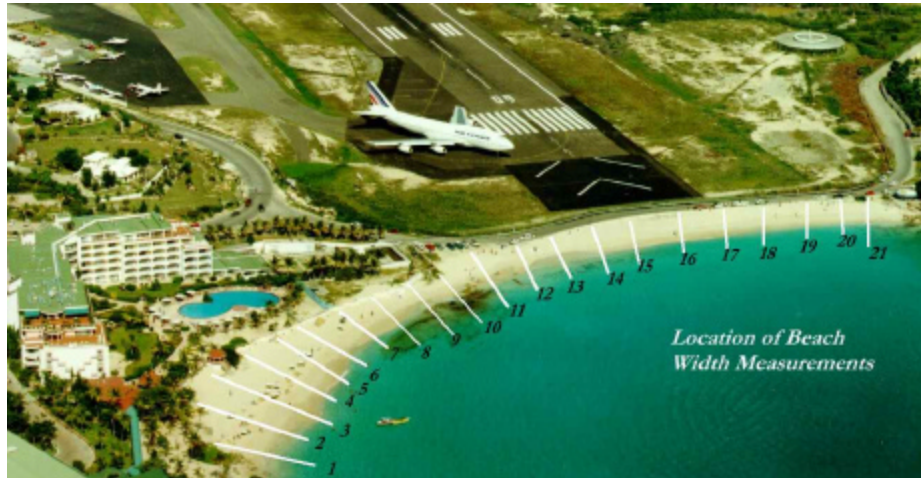
Figure 4. Location of beach width measurements.

Measurements of the existing beach width were taken on 22 February 2003 at 50-foot intervals along the beach from north to south. Figure 4 presents an aerial photograph of the Maho Beach area that shows the approximate locations of the beach width measurements, and Table 1 presents the beach width measurements.

Table 1 shows that the beach was approximately 1100 feet long with an average width of 50 feet (maximum width = 88 feet and minimum width = 0). Review of historical aerial

4. Beach width measurements and beach profile surveys are recommended to allow for monitoring of the Maho Beach area (and other beach areas around the island). Six reference points along the Maho Beach area can be chosen (such as seawall corners or other landmarks) from which measurements can be made at monthly intervals and following major storm and erosion events. This will provide data that will be helpful in improving the understanding of the coastal processes and developing solutions to beach erosion problems.

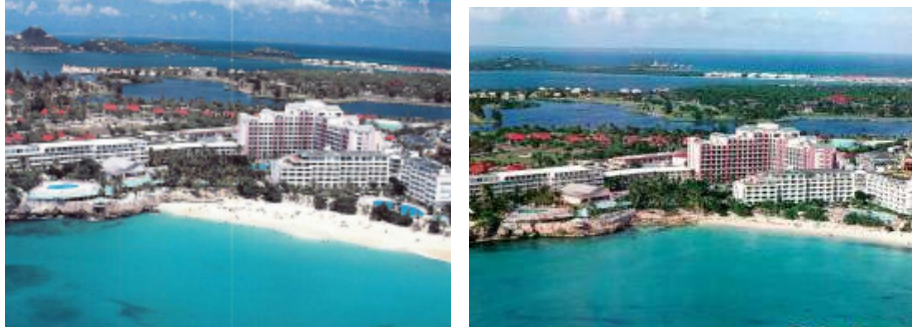
Figure 5. Previous wide beach (on left) and subsequent narrower beach (on right).

photographs reveals that the beach widths and shapes can vary considerably for Maho Beach, as seen in Figures 5 and 6.

2. The most sure and effective method for increasing the beach widths at Maho Beach is by adding sand to the beach. This can be done using beach compatible sand from an upland or offshore source. Costs and feasibility of beach nourishment is dependent upon the source and quality of available sand materials.

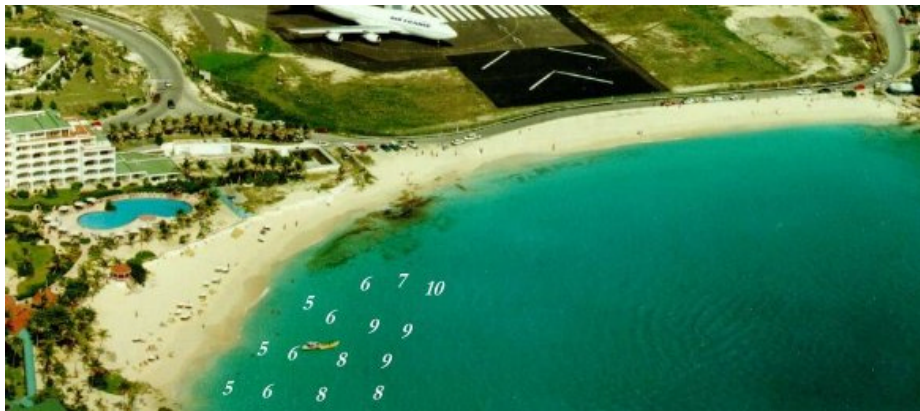
Figure 6. Water depths offshore of the Maho Beach Hotel and Casino.

Sea conditions were quite rough during the site survey, but water depth measurements were made by free diving with a depth gage. The water depths are shown in the approximate locations in Figure 6.

3. An offshore breakwater can be used to reduce the wave action reaching the beach, thereby reducing the wave energy and erosion of the shoreline. The difficulties with this alternative for the Maho Beach area are the deeper water depths and sand bottom offshore of the beach area. The deeper water depths require a greater structure height to be effective. The sand bottom presents a potential problem with scour and settlement of breakwater units. For this alternative to be considered further additional measurements of water depths and probes of the bottom to determine the depth down to rock need to be performed.
