**STATUS REPORT FOR THE SUBMERGED REEF BALL™
ARTIFICIAL REEF SUBMERGED BREAKWATER
BEACH STABILIZATION PROJECT FOR
THE GRAND CAYMAN MARRIOTT HOTEL**

performed by Lee E. Harris, Ph.D., P.E.
Consulting Coastal Engineer
Assoc. Professor of Ocean Engineering
Florida Institute of Technology
Melbourne, Florida 32901 USA

August 2003

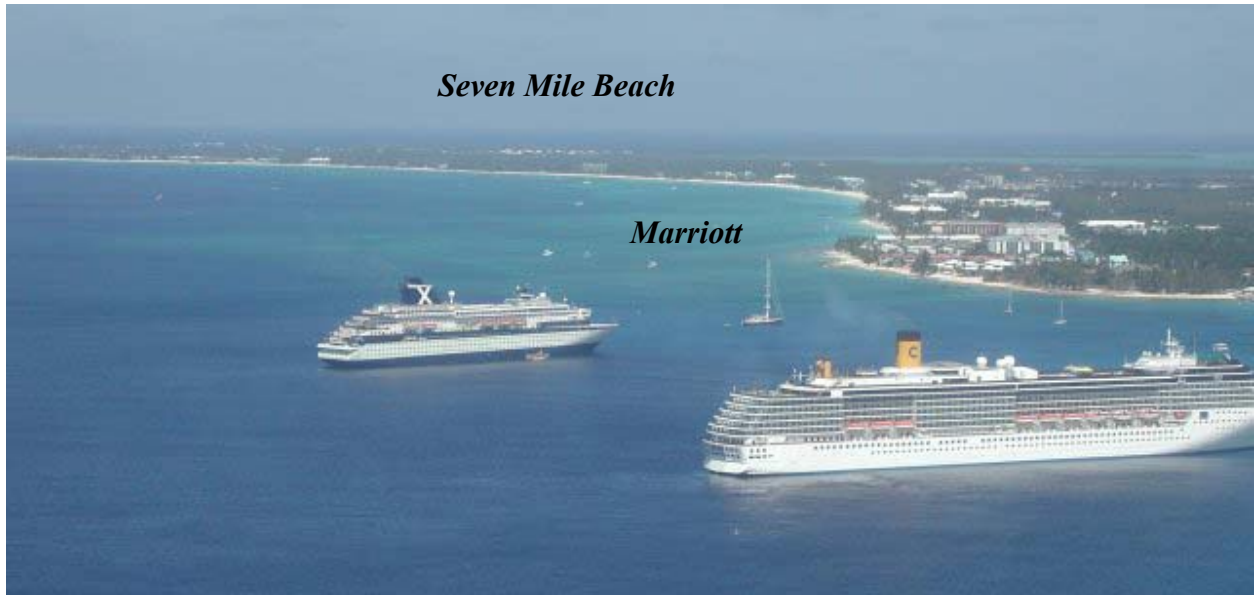
The Marriott Hotel lies at the southern end of Seven Mile Beach. The aerial photograph in Figure 3 shows a view north from the Port, with the locations of Seven Mile Beach and the Marriott Resort indicated. The beaches in the Seven Mile Beach area generally become wider as you go north from the Marriott Hotel to the central Seven Mile Beach area, while to the south there is only a short stretch of sand beach that is followed by a rocky shoreline as you approach the Treasure Island Resort. There also are some rock groins that were constructed in this area, as shown in Figure 4, and the shoreline here curves around to the east into the Port area. This rocky shoreline to the south of the Marriott, the reorientation of the shoreline, and the rock shoreline with no sediment source to the south prevents any potential transport of sand from the south to the Marriott's beaches.

This has resulted in the beaches in the southern Seven Mile Beach region to be particularly susceptible to erosion from waves coming from the southwest, due to the lack of sand along the coast to the south. Waves from the southwest, especially during storm events, transport sand from the southern end of the Seven Mile Beach area to the north. Waves from the northwest tend to transport sand to the south along the Seven Mile Beach area, which nourishes the beaches at

the south end (including the Marriott), but this occurs at a much slower rate than the erosion of sand accompanying southwest wave activity, and an increase in the frequency and magnitude of southwest waves over the past few years has prevented the beach from accreting out to the beach width that the Marriott had prior to 1996.

Figure 3. Aerial View North from the Port towards Seven Mile Beach

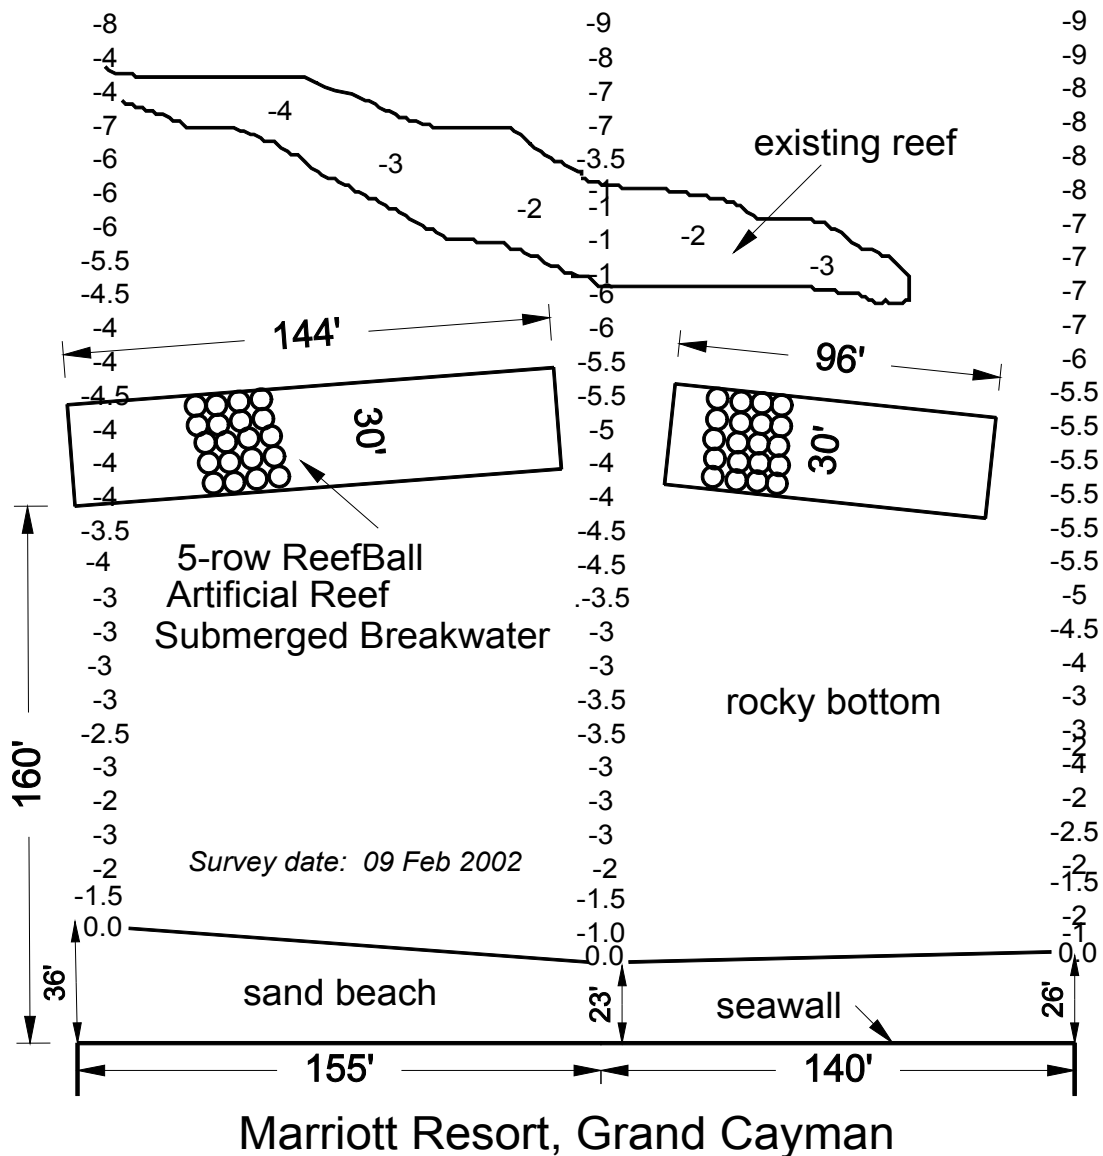
The recommended design shown in Figure 8 uses 5 rows of Reef Ball™ artificial reef units to provide a 30-foot wide submerged breakwater. The 3.7 to 4.5 feet high artificial breakwater units were installed in low tide water depths of 4 to 5.5 feet, so that the top of the units are slightly below the lowest normal water level (0.3 to 1.8 feet).

Figure 8. Original Reef Ball™ Artificial Reef Submerged Breakwater Design
