Designs for Artificial Reef Sites in the Indian River Lagoon Martin County, Florida

Lee E. Harris, Ph.D., P.E.
Consulting Coastal Engineer
310 Ormond Avenue
Indialantic, FL 32903

February 2002

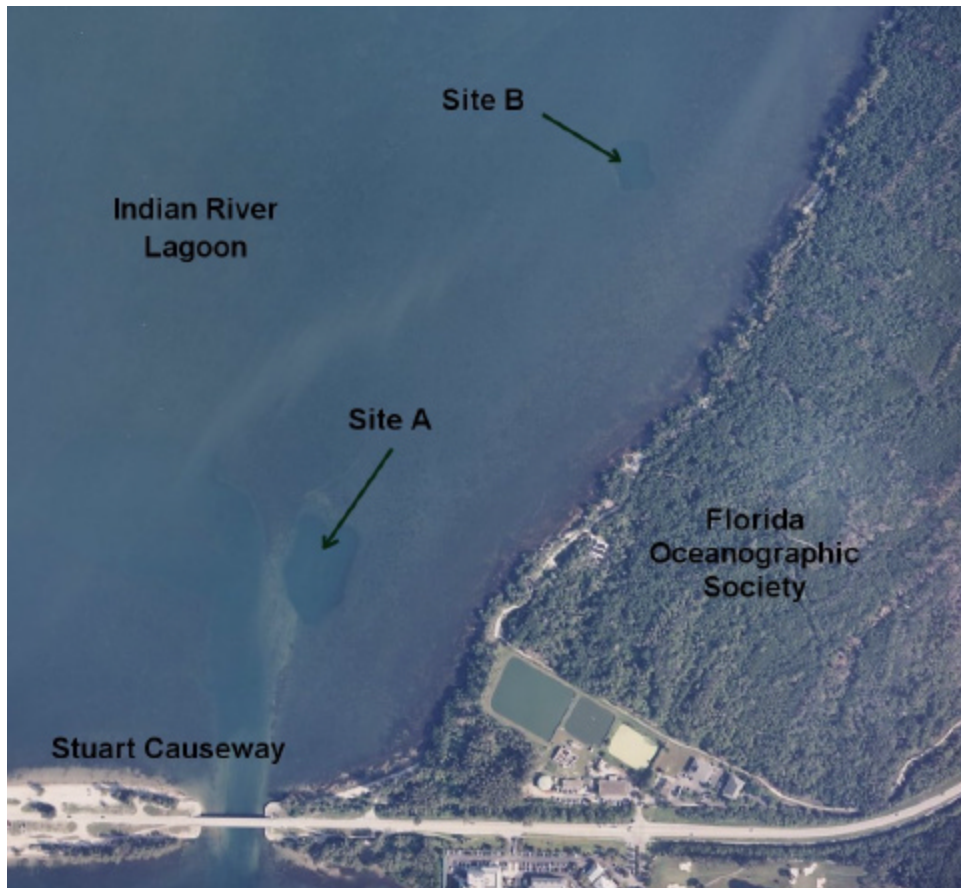
Figure 1. Locations of the Stuart Causeway Potential Artificial Reef Sites

At the eastern end of the Stuart Causeway there are two dredged holes north of the causeway, as shown in the Figure 1. Each of these 2 sites are approximately 600 feet offshore of the Hutchinson Island shoreline.

From the diver surveys of the two sites at the east end of the Stuart Causeway in the Indian River lagoon, the southern Site A was found suitable for artificial reefs, but the northern Site B was found unsuitable. Site B has sufficient depths, but the soft mud bottom with 30 inches and more of penetration into the bottom by hand would not provide support for artificial reef units.

The southern Site A was found to be suitable for artificial reef placement. This site is approximately 400 feet long and 250 feet wide which is about 2.2 Acres, and has an average depth of over 12 feet below MLLW. No seagrasses were found growing on the bottom of Site A, and the bottom is sand and firm mud, with only 1.5-inches of penetration by hand, so that sinking of reef units into the bottom would be minimal. The adequate water depths, firm substrate, and absence of seagrasses make Site A suitable for artificial reefs.

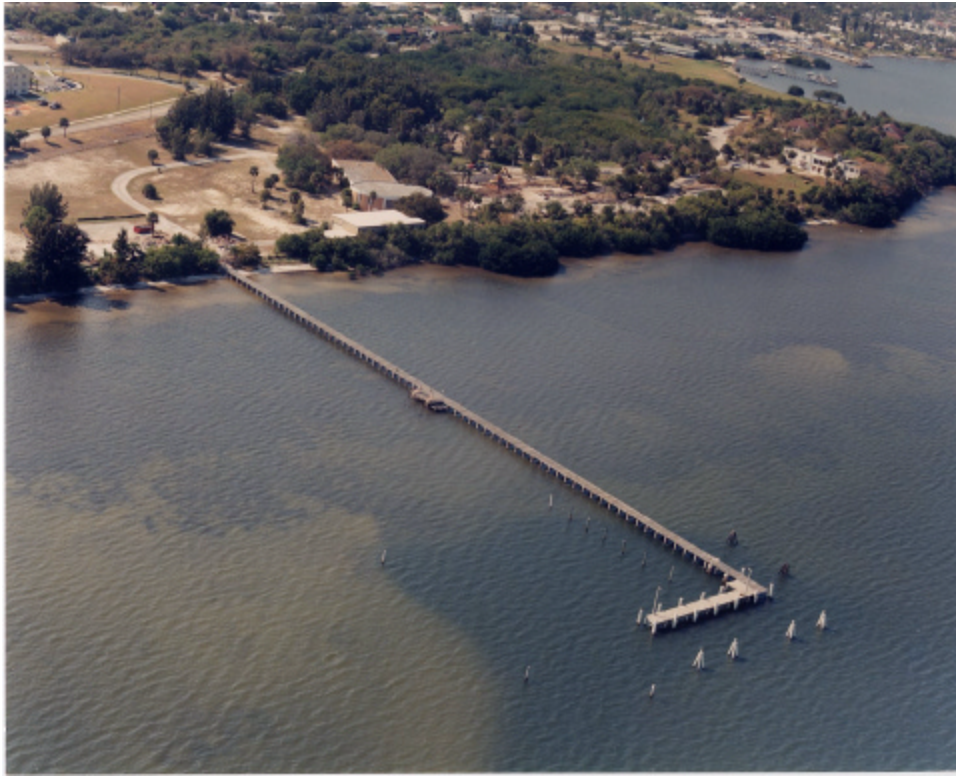
Figure 4. Pier at Indian Riverside Park

The area offshore of the Indian Riverside Park was investigated for possible artificial reef sites. Most of the area was too shallow and full of seagrasses, except for some areas around the existing pier structure. This area in the Indian River is shown in the aerial photograph in Figure 4.
